# **Automated Safety Warning Controller**

## **Final Report**

State of California, Department of Transportation  
Division of Research and Innovation

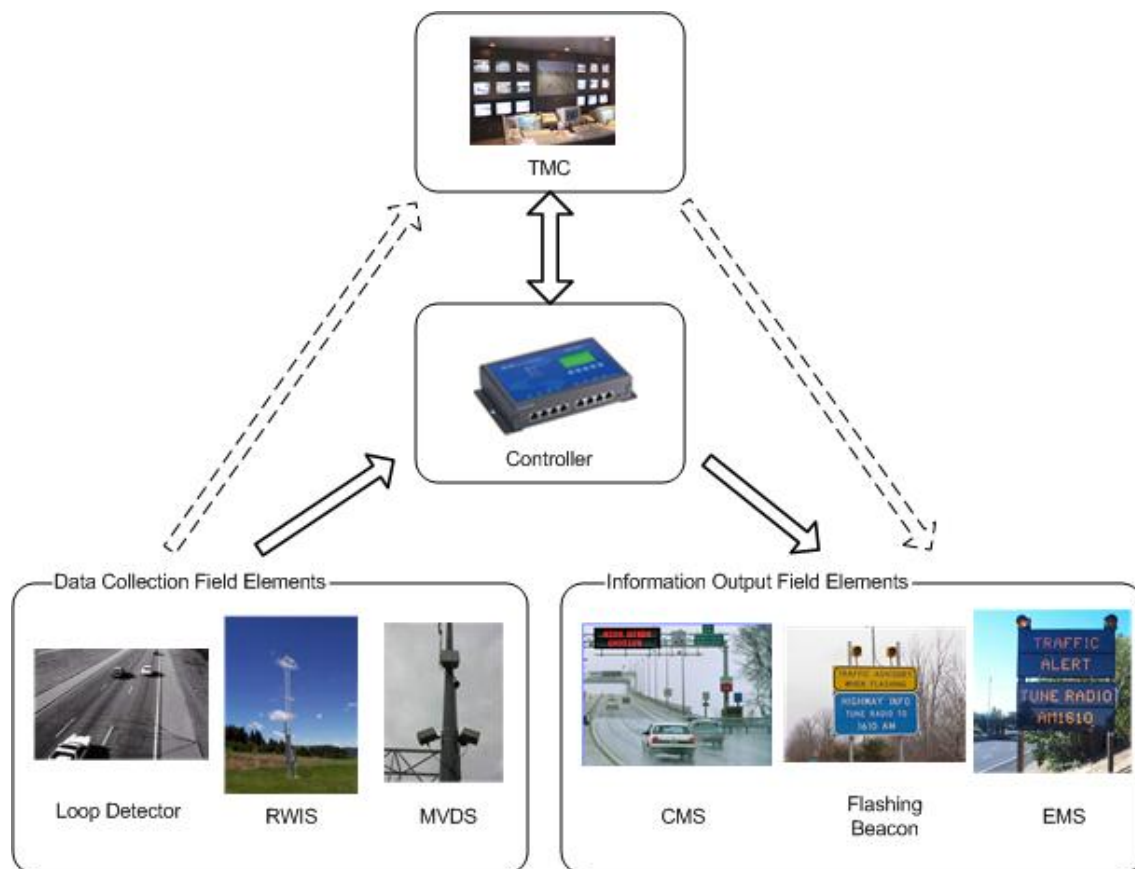
The goal of this project was the development of a system that frequently and automatically monitors field element data and determines, according to best practice algorithms, if a warning should be activated. The automated warning controller device would be installed near the warning devices it controls, so the system could continue to work even if communication with the RTMC is disrupted. The controller can also poll field elements much more frequently than a RTMC operator and quickly and automatically make the decision whether to activate a warning based on the retrieved information. Another goal of this project was to develop a standardized system that is versatile enough to be used at any location, with any number and type of field elements from which to draw data. Figure 1 shows an early conceptual diagram of the system.

Figure 1: Controller Interaction with TMC and Field Elements

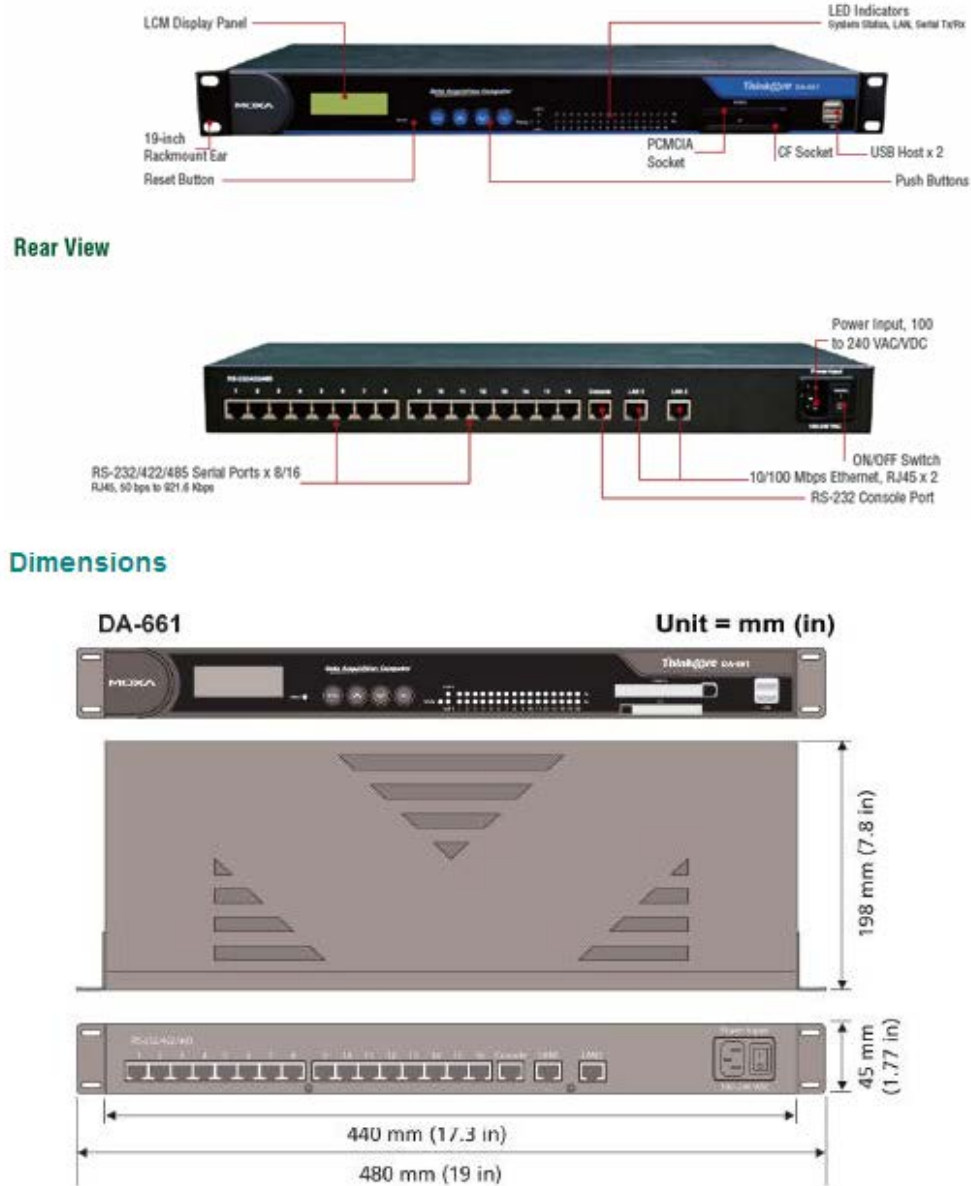
For this phase of the project, Caltrans requested the use of a rack mount device consistent with Caltrans roadside network equipment mounting. The Moxa DA-661 was selected due to its compatibility with the UC-7420 used in Phase 1. Figure 2 shows the Moxa DA-661.

**Figure 2: Moxa DA-661 Embedded Computer (image courtesy of Moxa)**

The main difference between the UC-7420 used in Phase 1 and the DA-661 is the size of the display and number of front panel buttons. Improving the front panel interface was one of the items identified from Phase 1, modifying it for the fewer buttons and smaller display size of the DA-661 added to the challenge of making an informative and intuitive interface. The front panel interface was re-done to be easy to understand and use for the occasional user such as a field

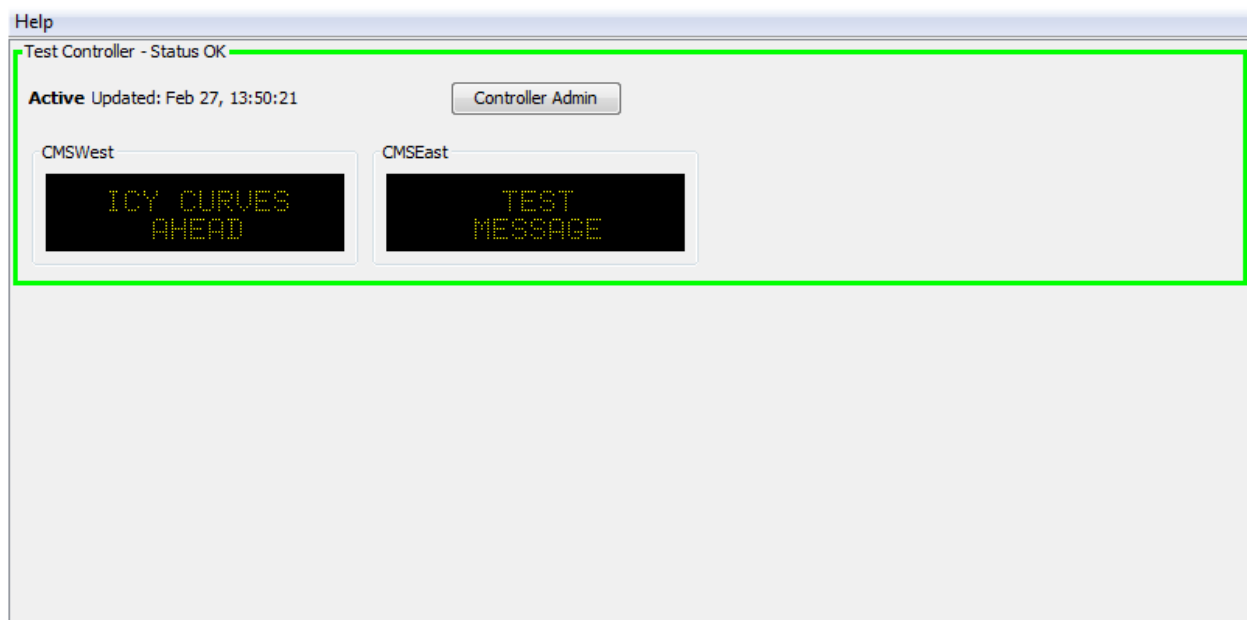
The SOCCS ASWC user interface was implemented as a Java applet running on a PC browser and served up by a separate TMC housed server. The SOCCS ASWC user interface was implemented as a summary screen and administrative screen. Multiple ASWCs can be configured and will be listed on the summary screen. The summary screen gives a quick look at the status and CMS message(s) for the configured ASWC, see Figure 3. The summary screen establishes an unauthenticated connection with the ASWC, retrieves the status and CMS message data, and then closes the connection. The update interval is configurable to optimize the usage of dialup lines. The administrative screen is accessed by demand and requires a username/password combination to establish an authenticated connection with the ASWC. The administrative screen gives operator and supervisor level access to the ASWC as defined in the Automated Safety Warning Controller System Concept and Requirements Specification (3). This screen allows the user to view detailed status of the running modules, view log messages, view values of input module sensors, and add a message to the CMS.

**Figure 3: SOCCS ASWC Summary Screen**

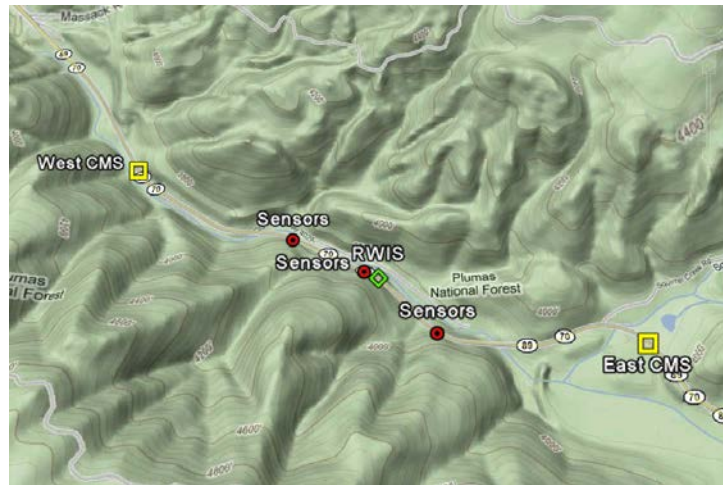
There is an RWIS at the Spring Garden with six in-pavement surface sensors deployed at three locations spanning approximately one-half mile. The West CMS is one-half mile west of the first surface sensor and the East CMS is a little over one-half mile east of the last surface sensor.

**Figure 5: Spring Garden Field Element Configuration**

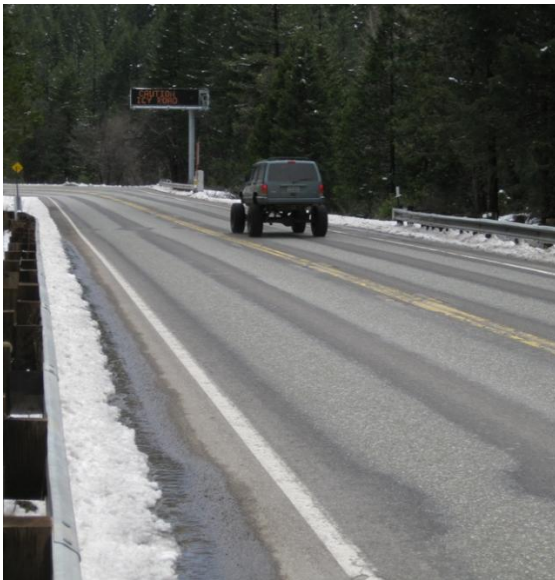
**Figure 6: Eastbound CMS (photo by Ian Turnbull)**

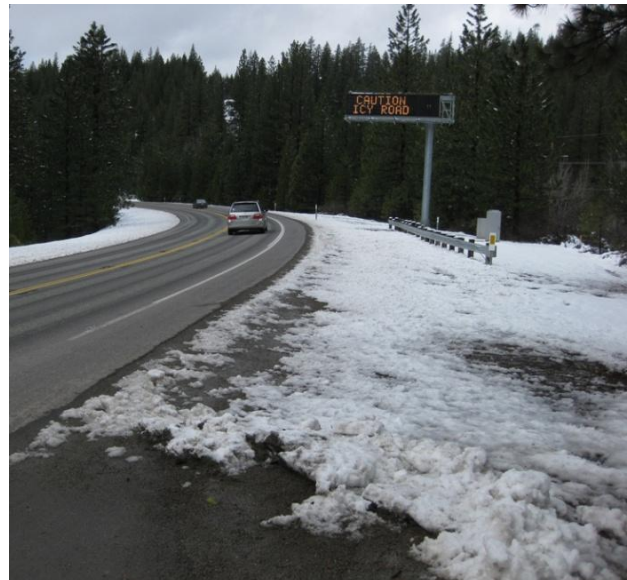
**Figure 7: Westbound CMS (photo by Ian Turnbull)**

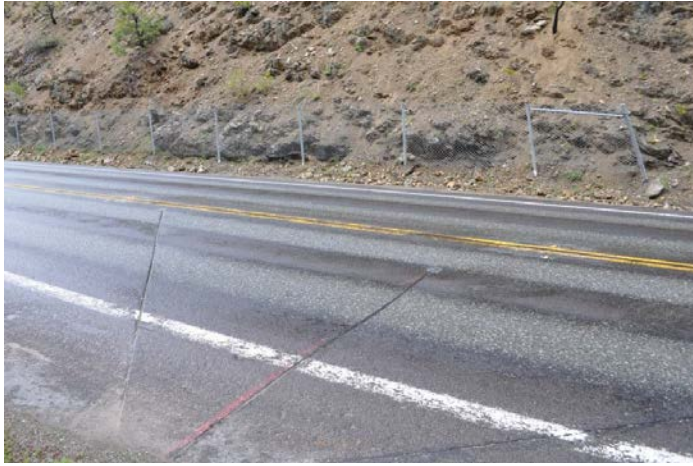
**Figure 8: Pavement Surface Sensors**

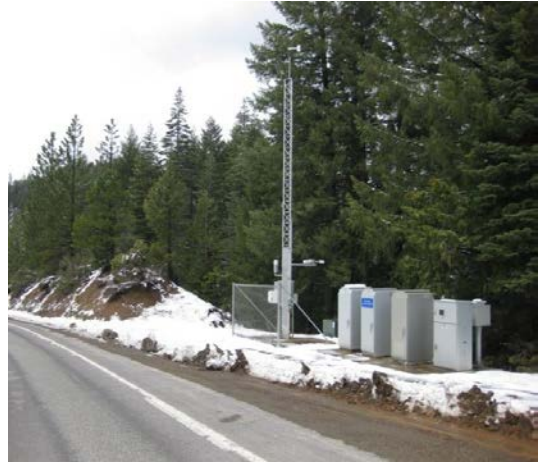
**Figure 9: Spring Garden RWIS (photo by Ian Turnbull)**

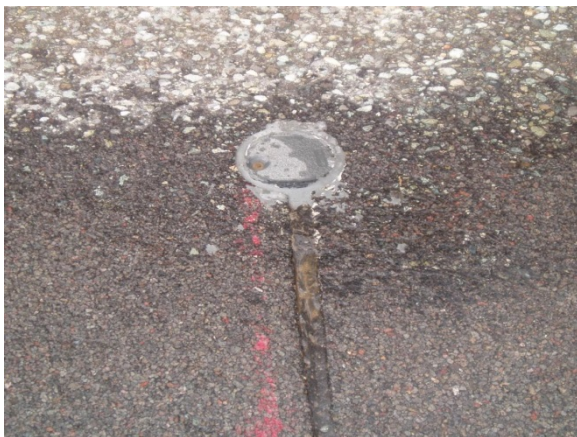
**Figure 10: Pavement Surface Sensor**

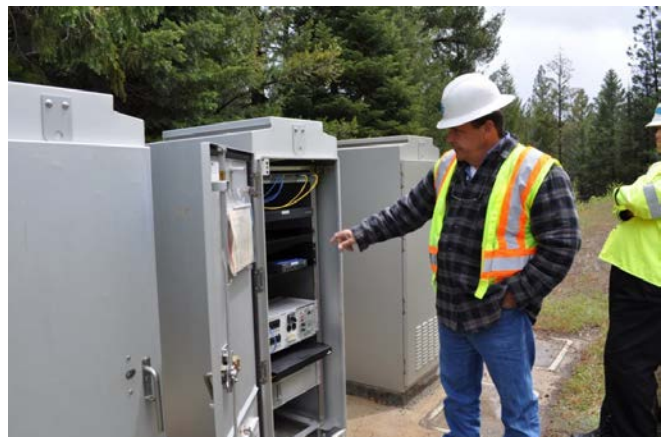
**Figure 11: ASWC in Spring Garden ITS Cabinet, as shown by Ian Turnbull**

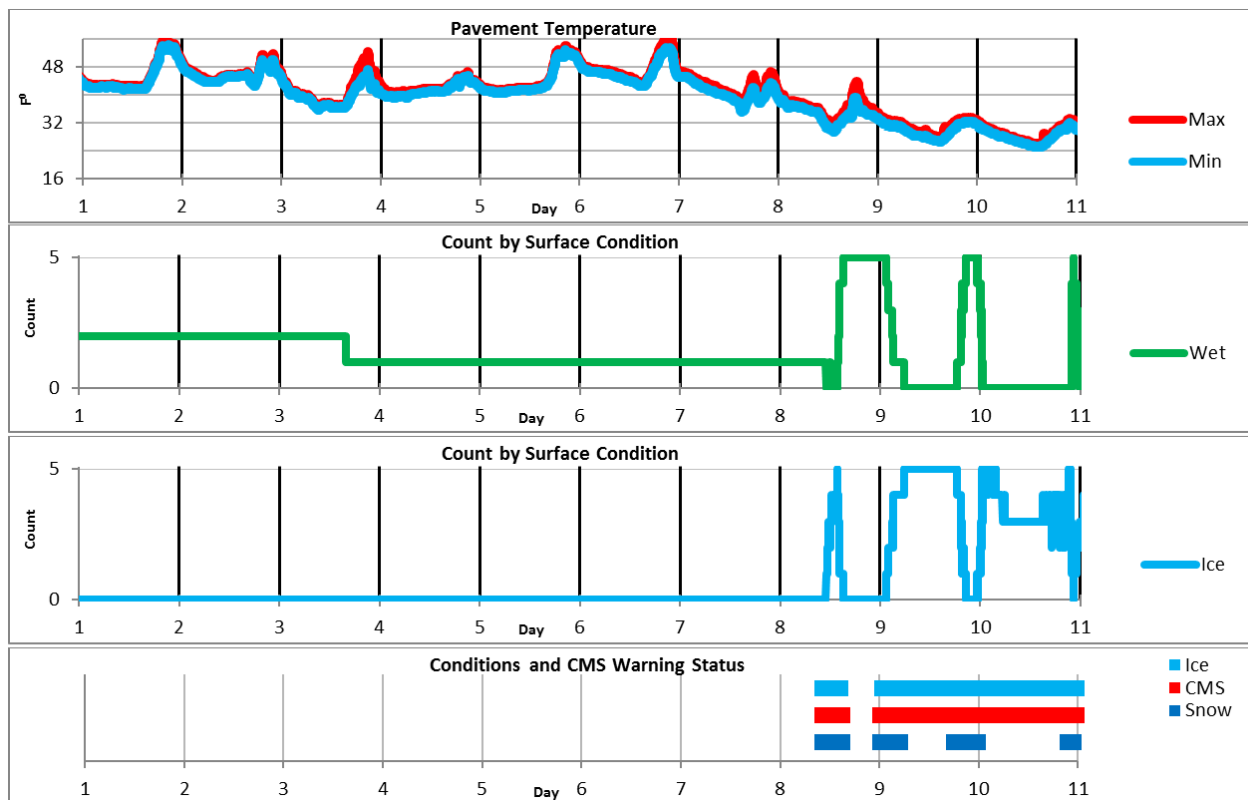
During the first seven days, no warning messages were displayed. Although several of the sensors detected “Wet” condition, temperatures were above freezing. On the 8<sup>th</sup> through 10<sup>th</sup> days, the warning message was triggered due to primarily to Ice conditions (Ice Warning, Ice Watch or Frost). When temperatures rose above freezing, the warning message was taken off the sign. At the end of the 8<sup>th</sup> day and throughout the entire 9<sup>th</sup> and 10<sup>th</sup> days Ice conditions were present and the warning message was displayed. Note that the “Snow” condition, which corresponds to “Wet” and temperature below 32.5 degrees was intermittent during this time. Ice conditions were reported on as many as 5 of the sensors during this time. Note further that one of the surface sensors was reported invalid values, so these summaries only include five of the surface sensors.

**Figure 16: Conditions and Warning Status for 2012-12-01 through 2012-12-10 GMT (pavement temperatures in °F, “Count” is the number of sensors reporting the given conditions)**

The project team examined in detail the operation of the ASWC throughout December 2012 to verify that warning messages were invoked during conditions matching the alert logic. The following plots show this analysis and confirm correct operation of the ASWC. Note that times and day breakdowns correspond to GMT.

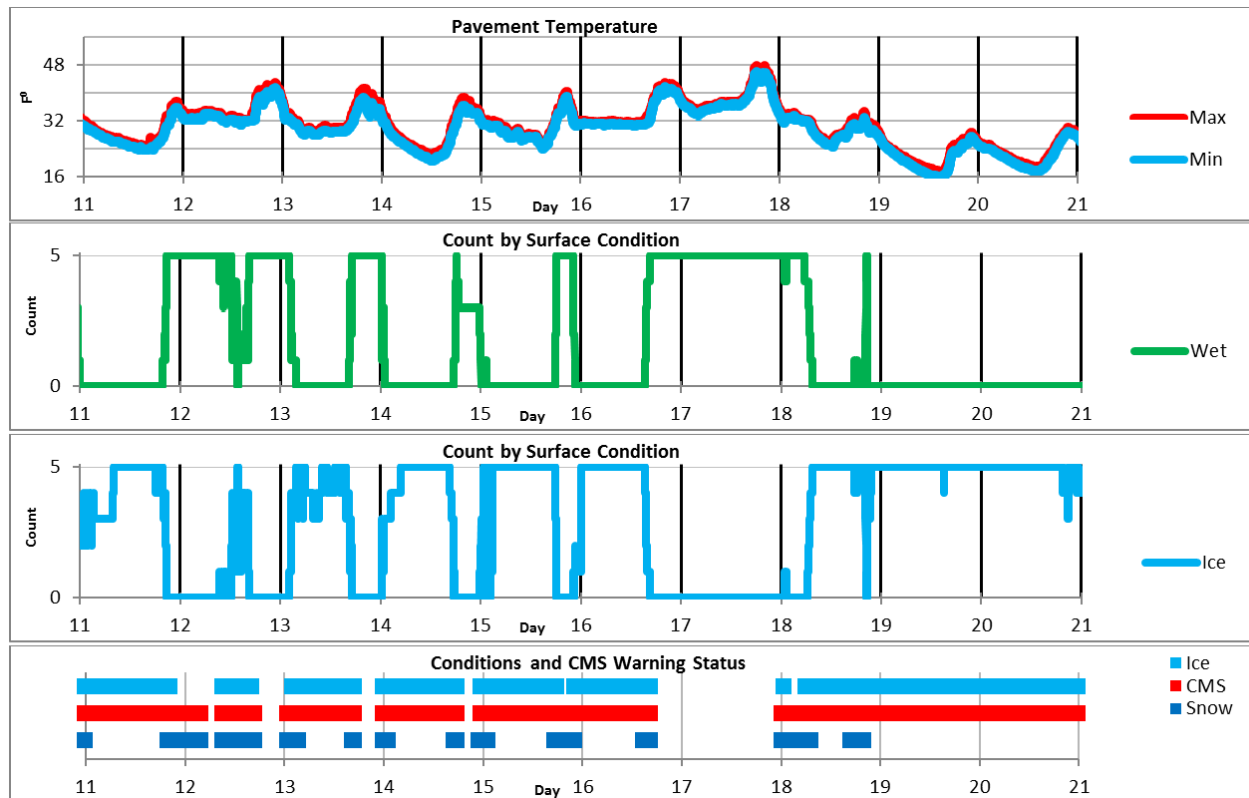
Warning messages were invoked over most of the 11<sup>th</sup> through 20<sup>th</sup> days, with the exception of most of Day 17, when temperatures were above freezing. Note that several times, particularly at the end of day 11 and the beginning of Day 12, Ice conditions were not present but snow conditions were. During days 15 and 18, Snow conditions caused the warning message to remain on the signs during short periods in which ice conditions were not reported.

Figure 17: Conditions and Warning Status for 2012-12-11 through 2012-12-20GMT (pavement temperatures in °F, “Count” is the number of sensors reporting the given conditions)

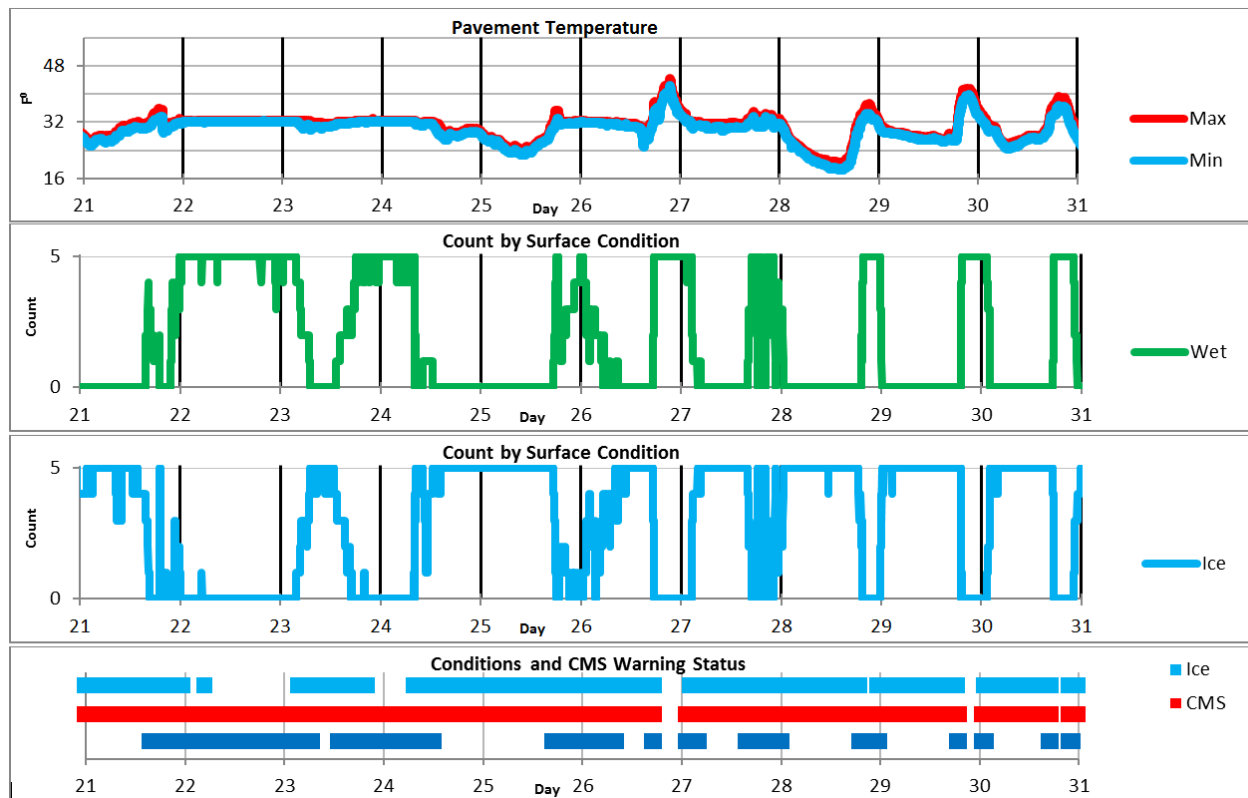
Days 21 through 30 showed similar behavior, with warning messages active for all but a short interval on Day 26, another on Day 29, and a very short time on Day 30.

**Figure 18: Conditions and Warning Status for 2012-12-21 through 2012-12-30GMT (pavement temperatures in °F, “Count” is the number of sensors reporting the given conditions)**
