# **Automated Safety Warning Controller**

## **Final Report**

State of California, Department of Transportation  
Division of Research and Innovation

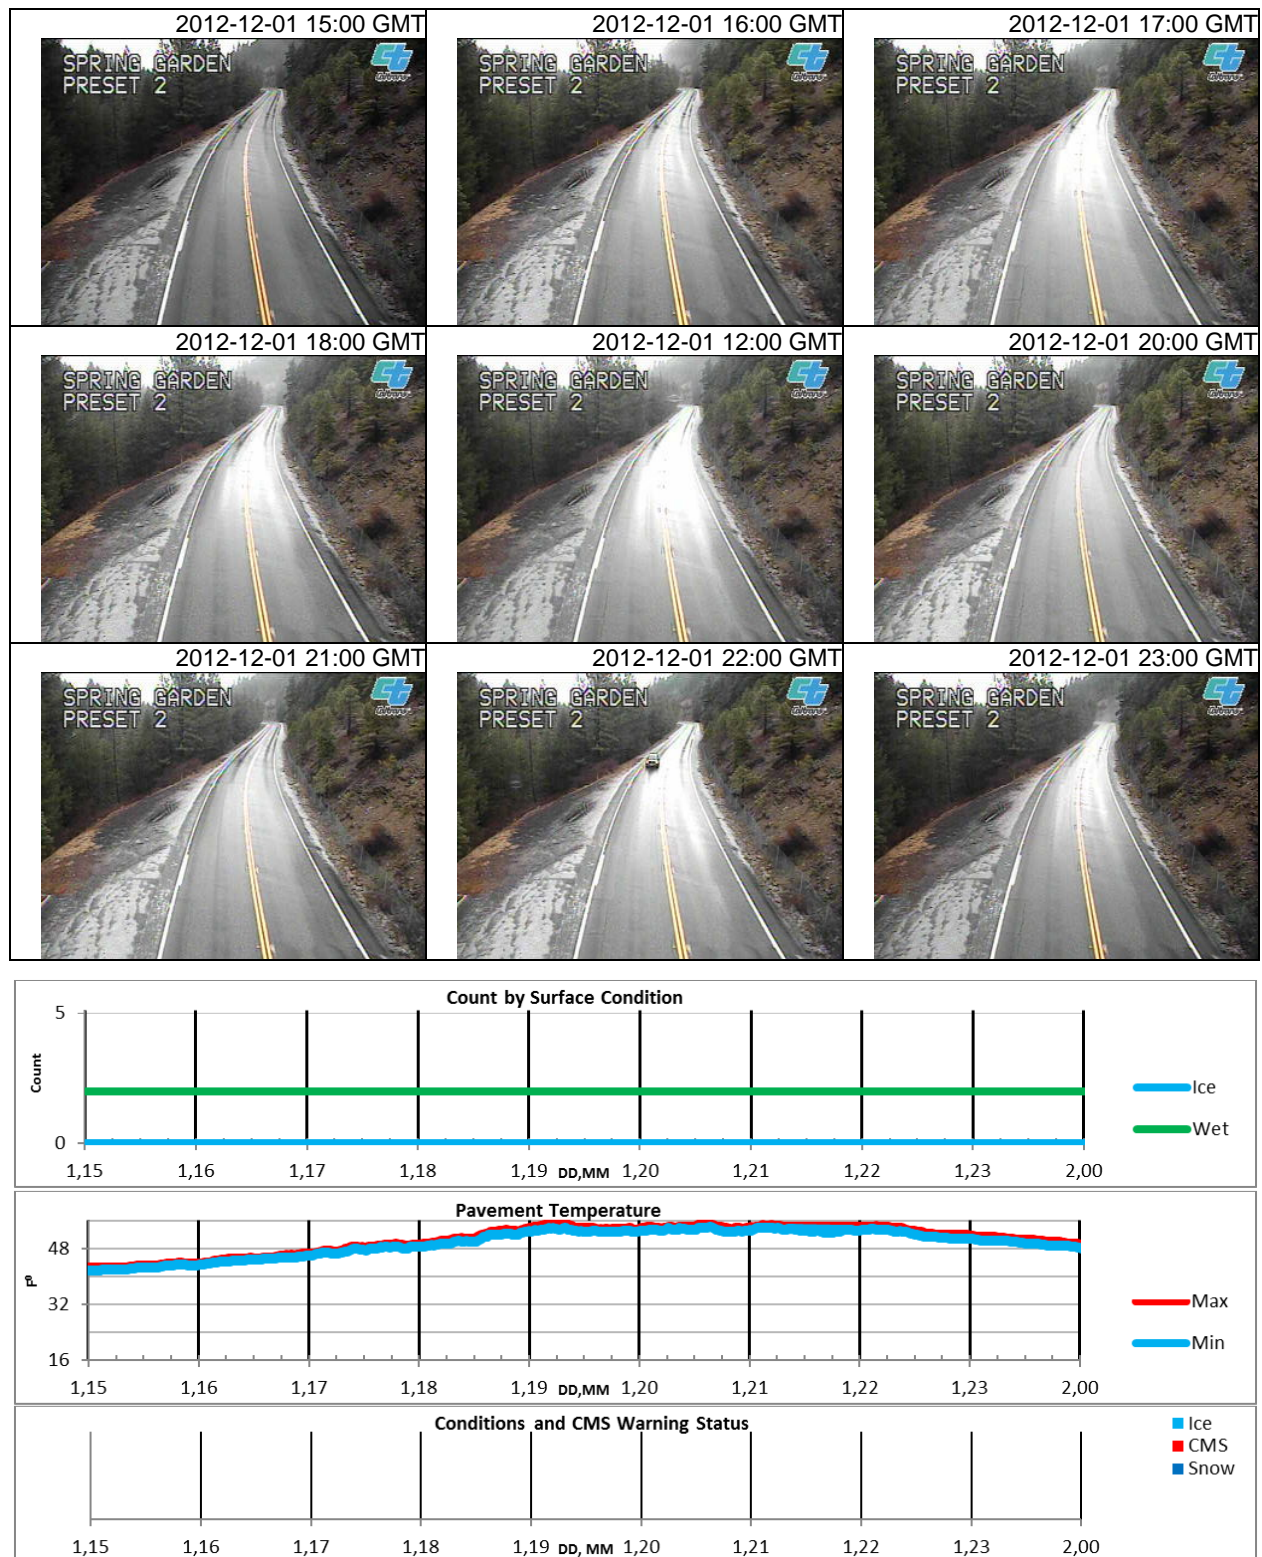
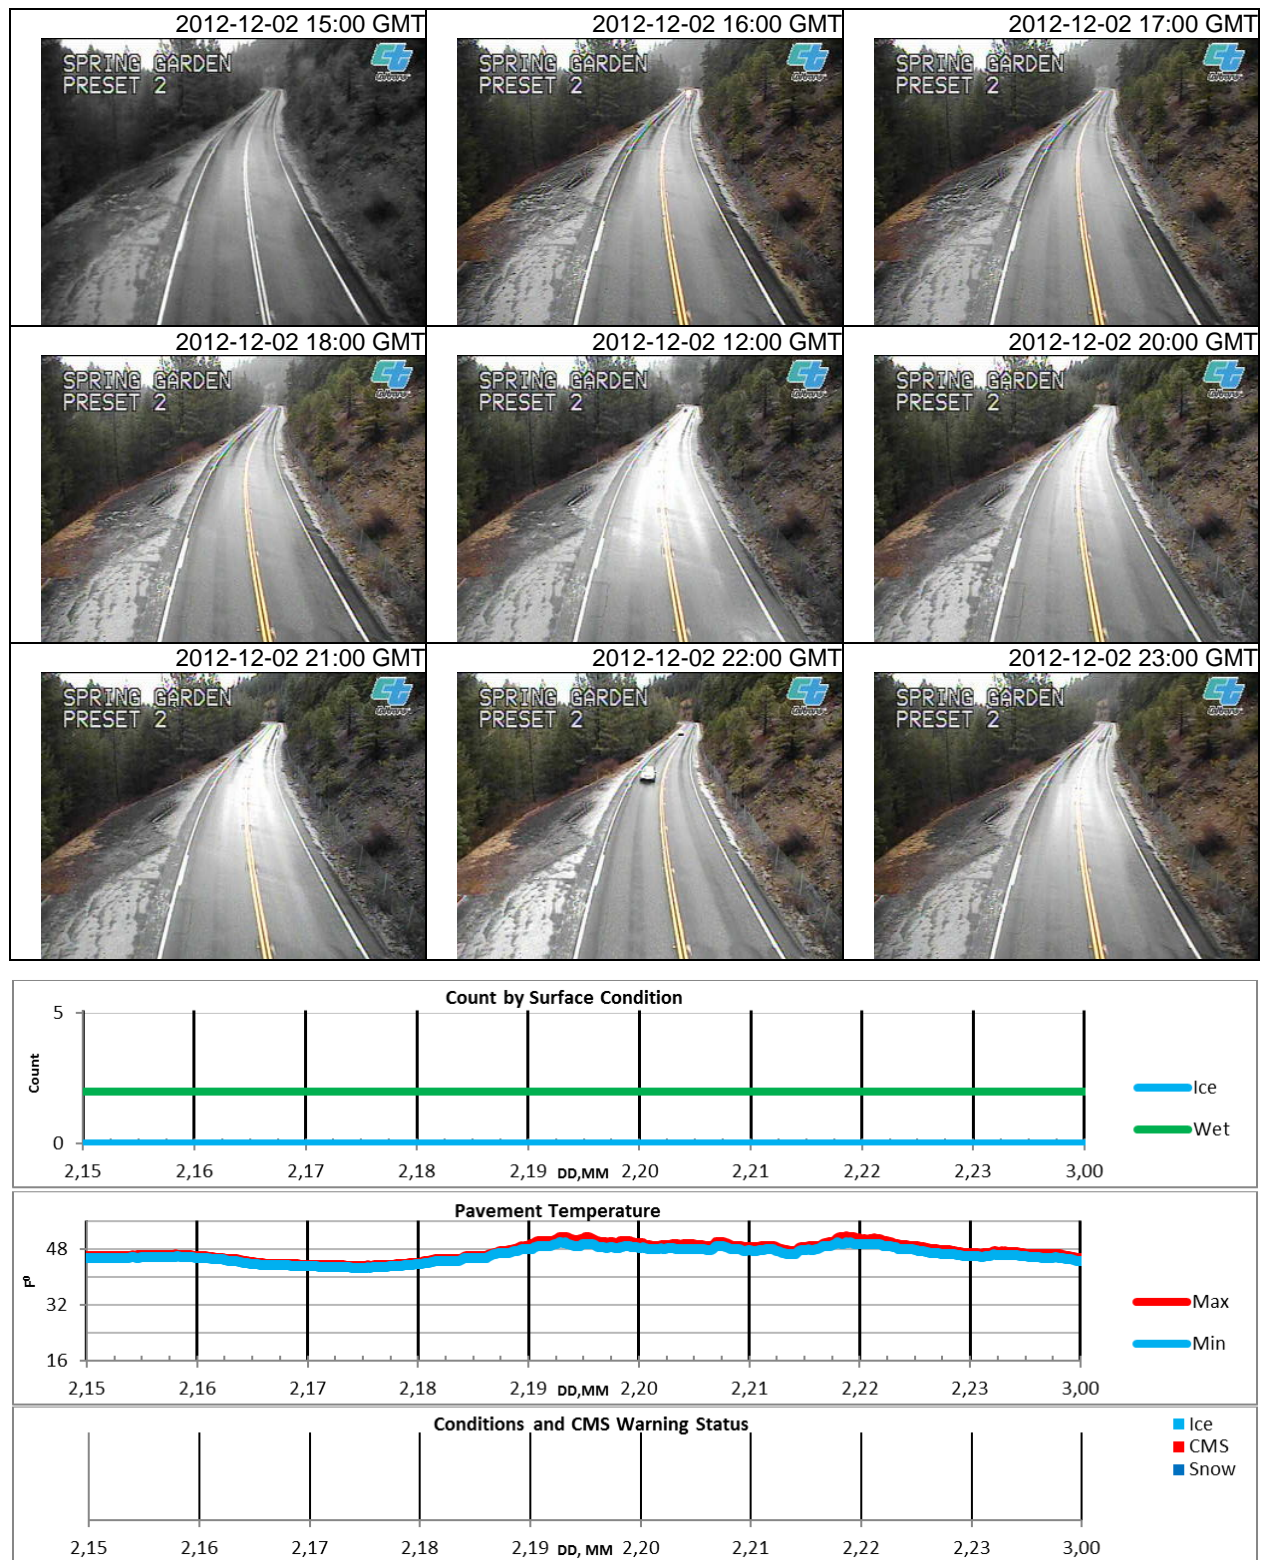
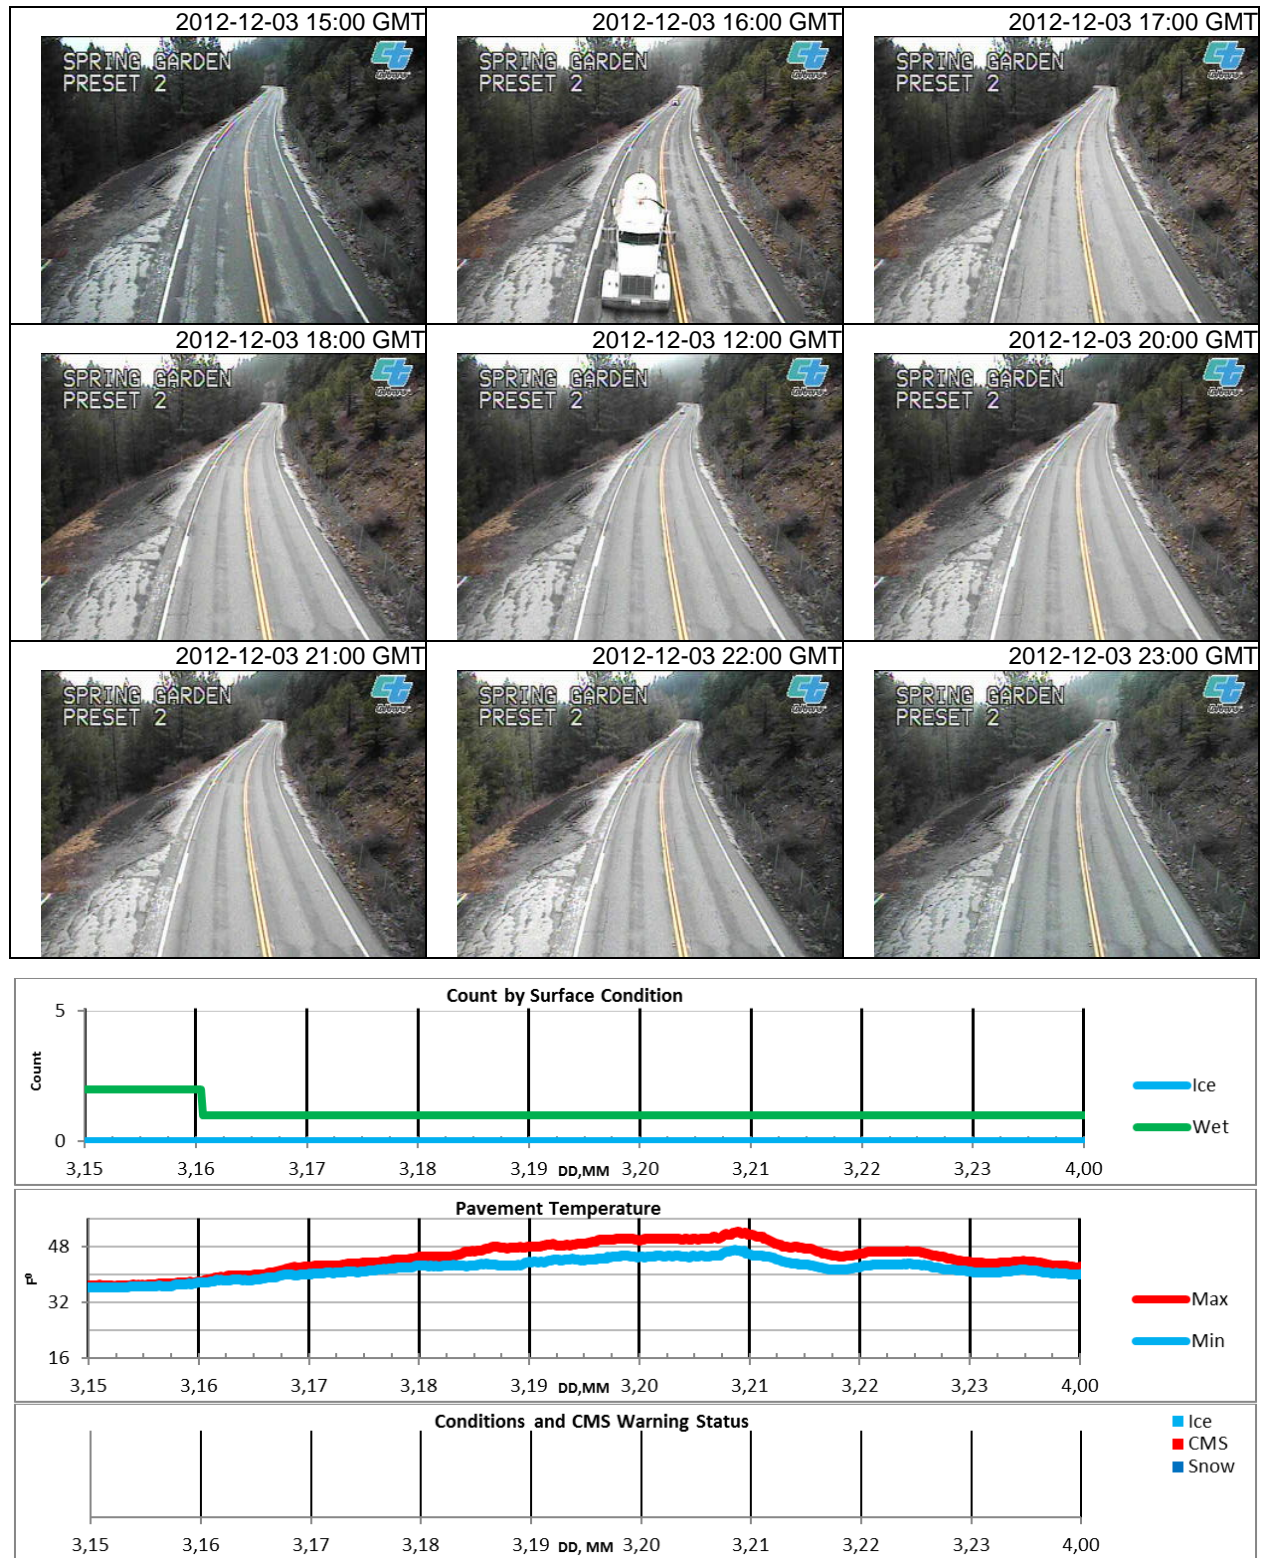
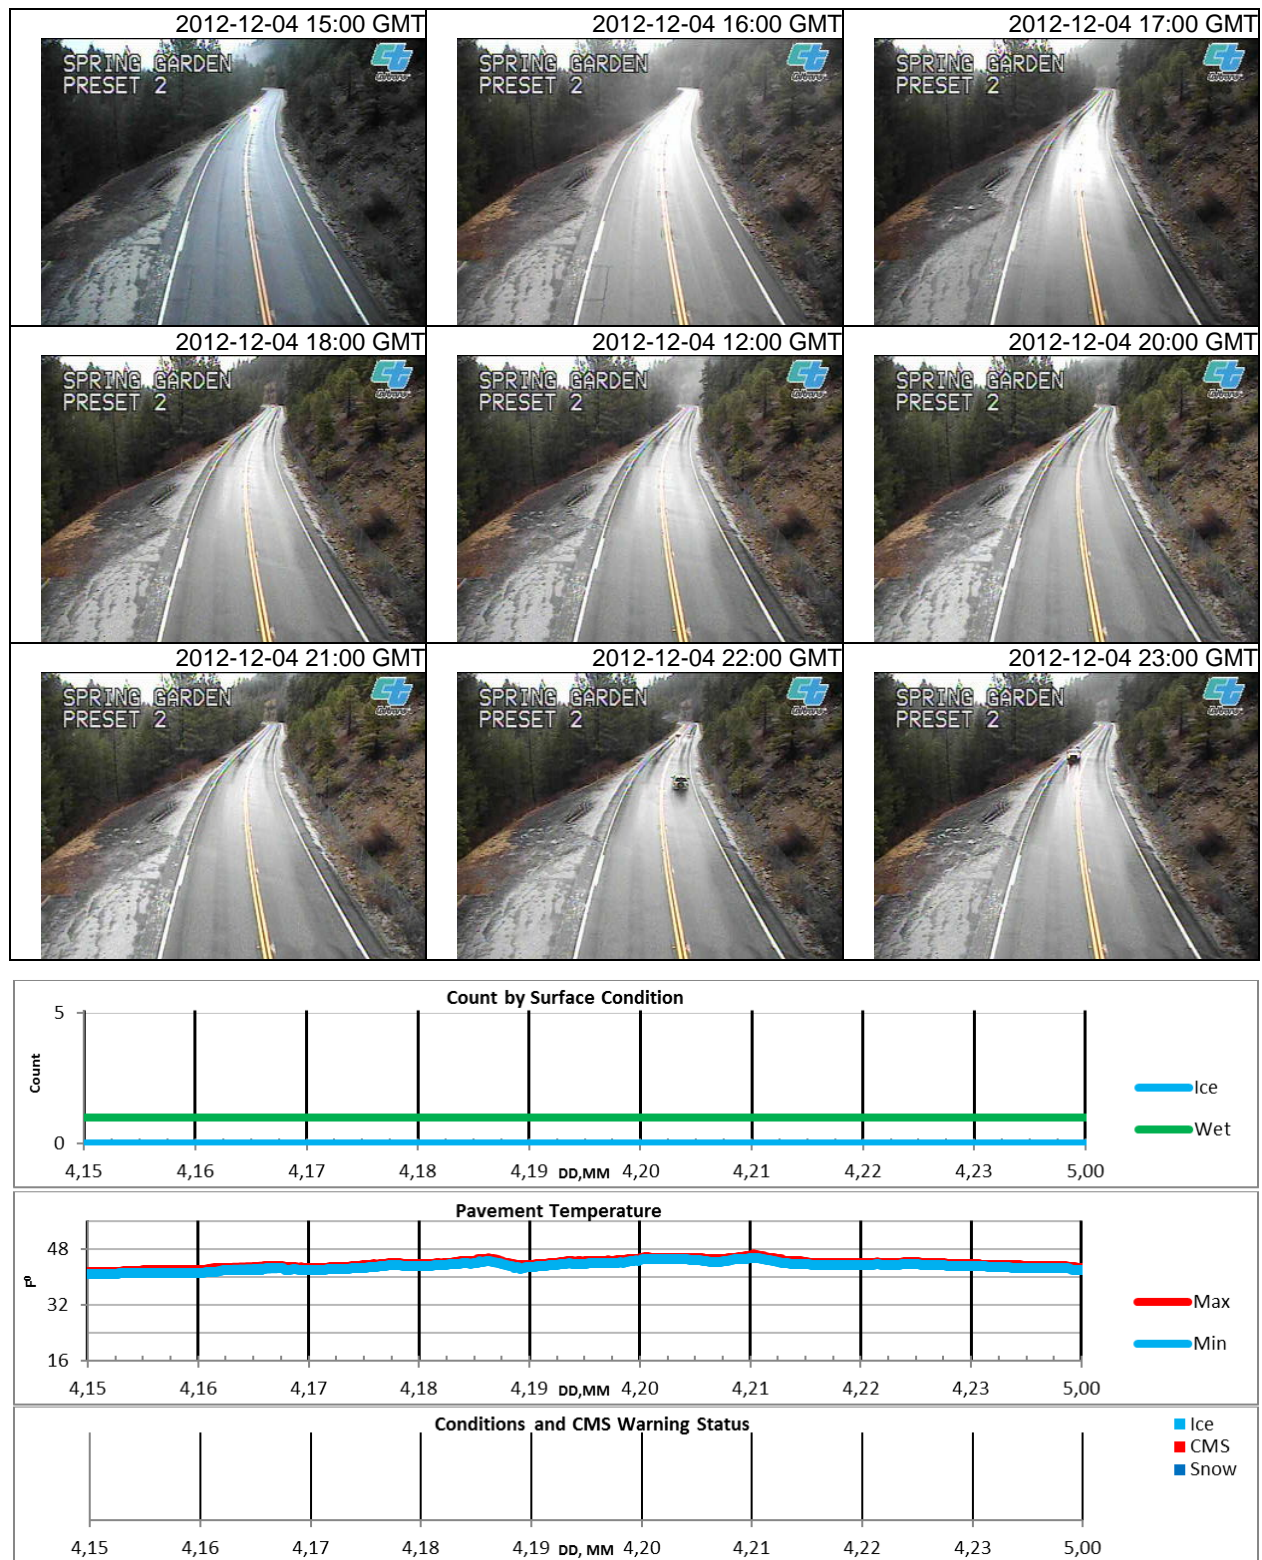
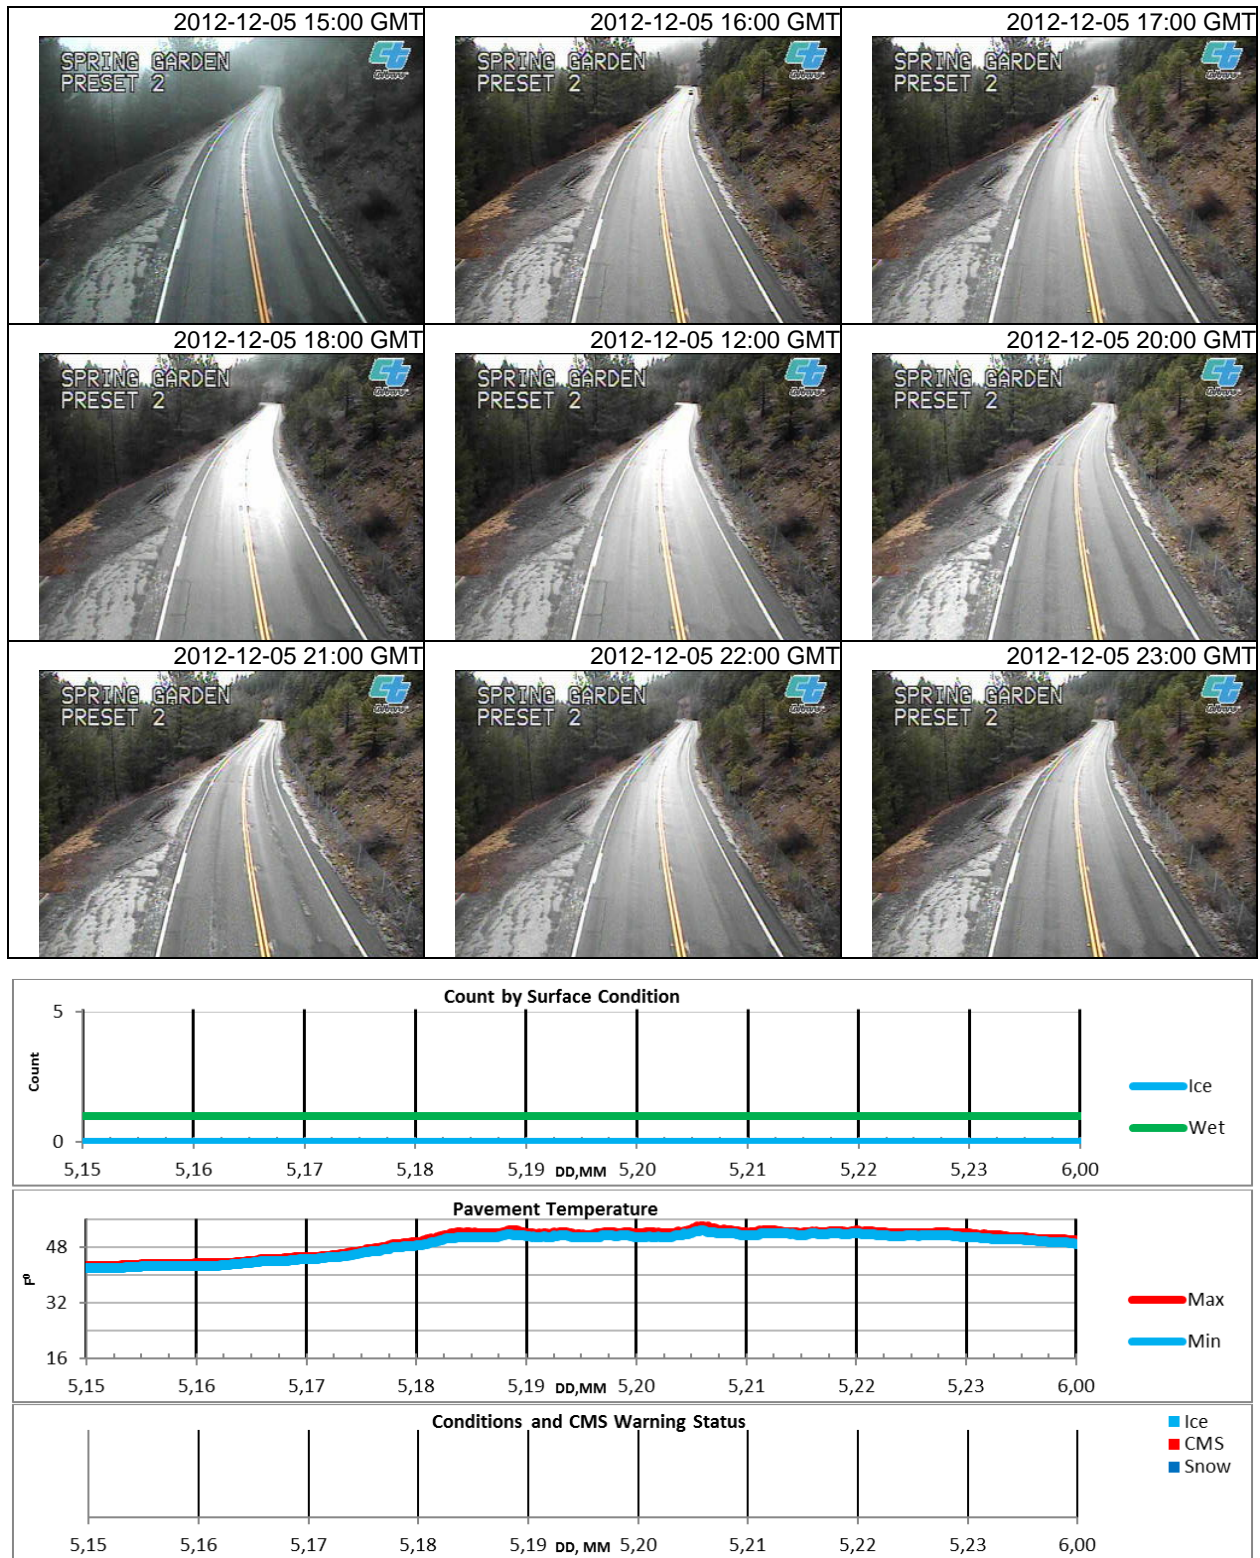
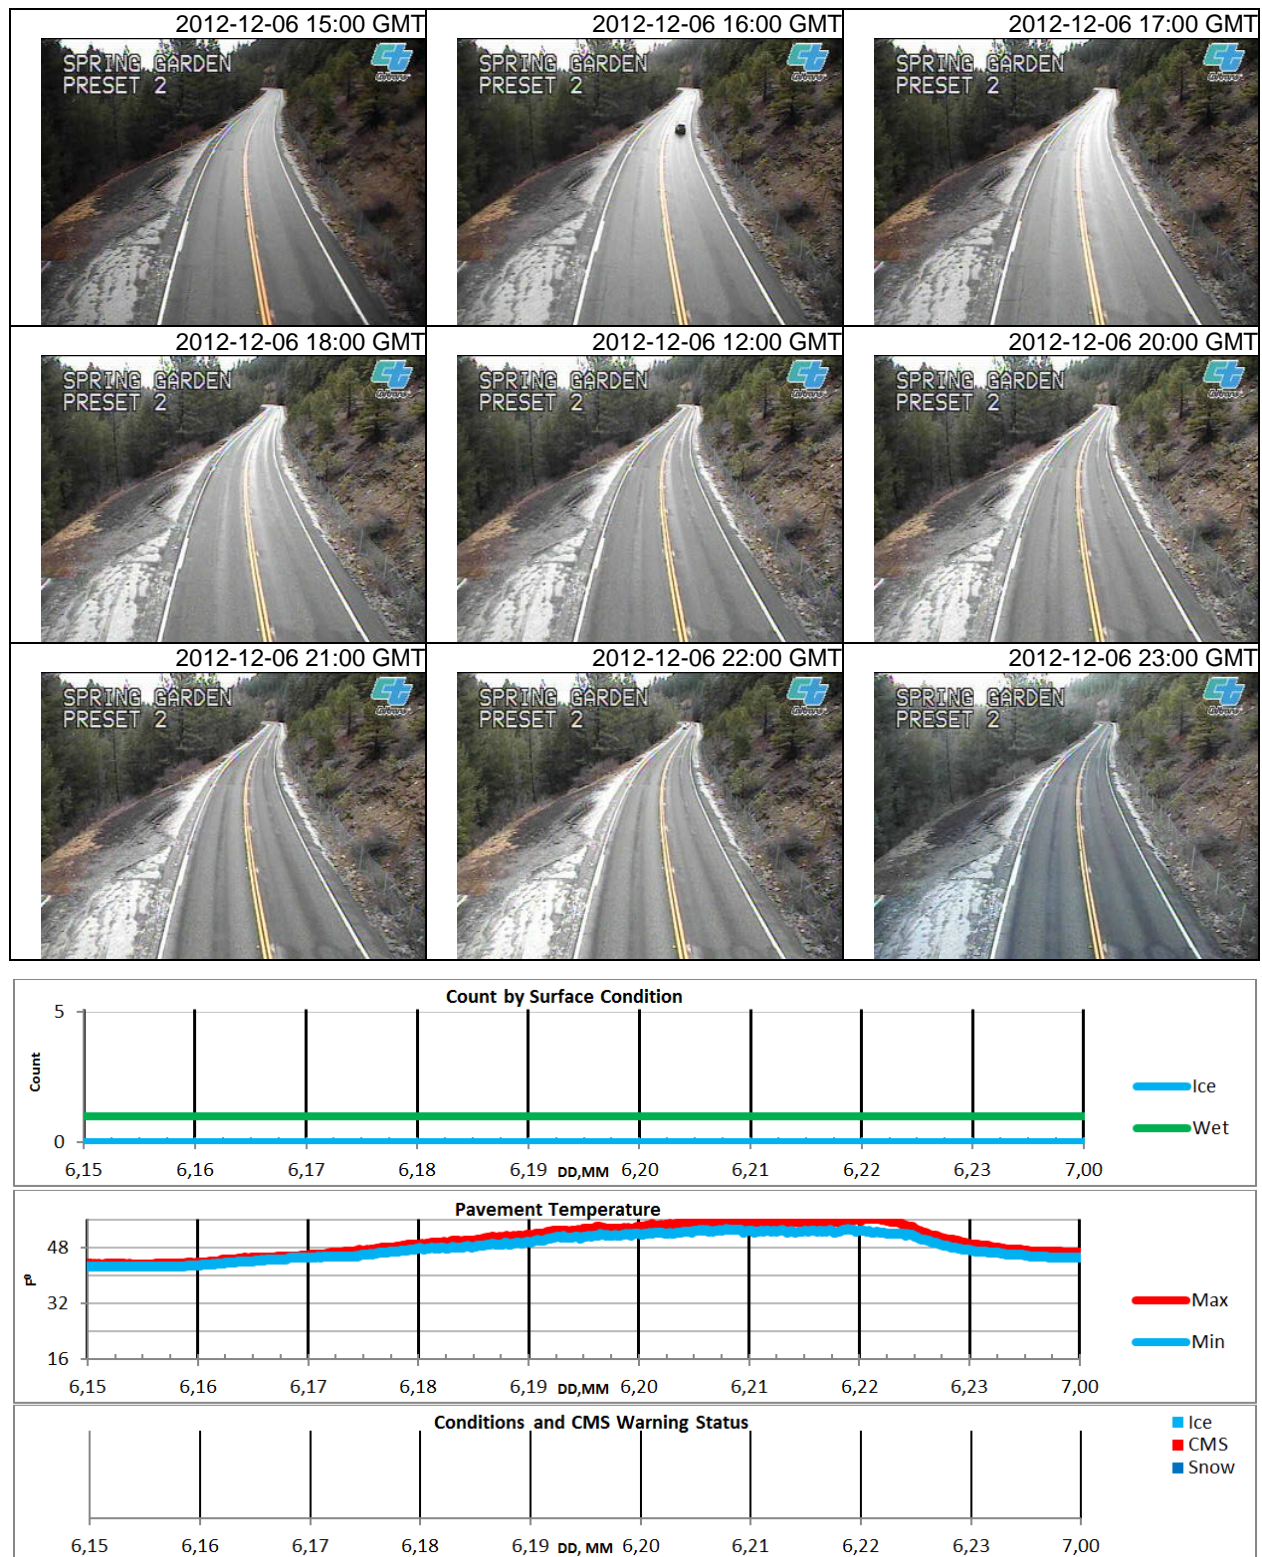
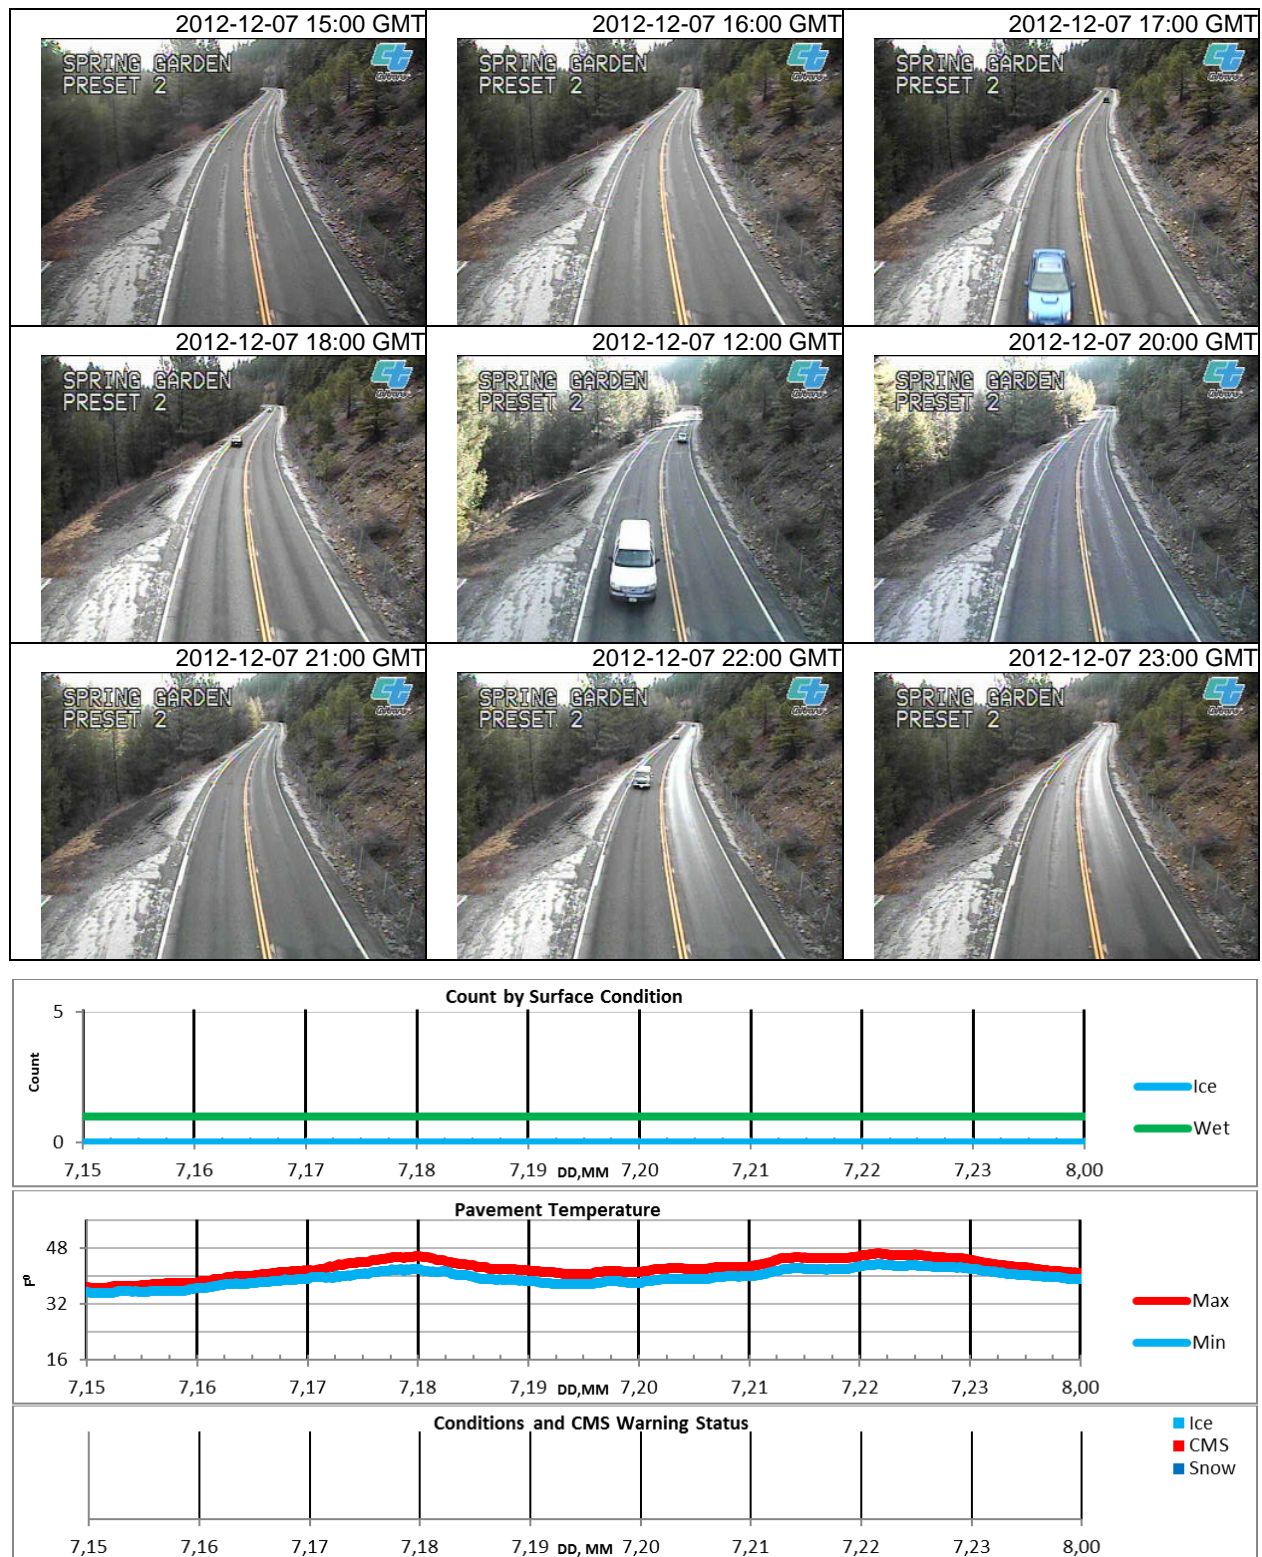
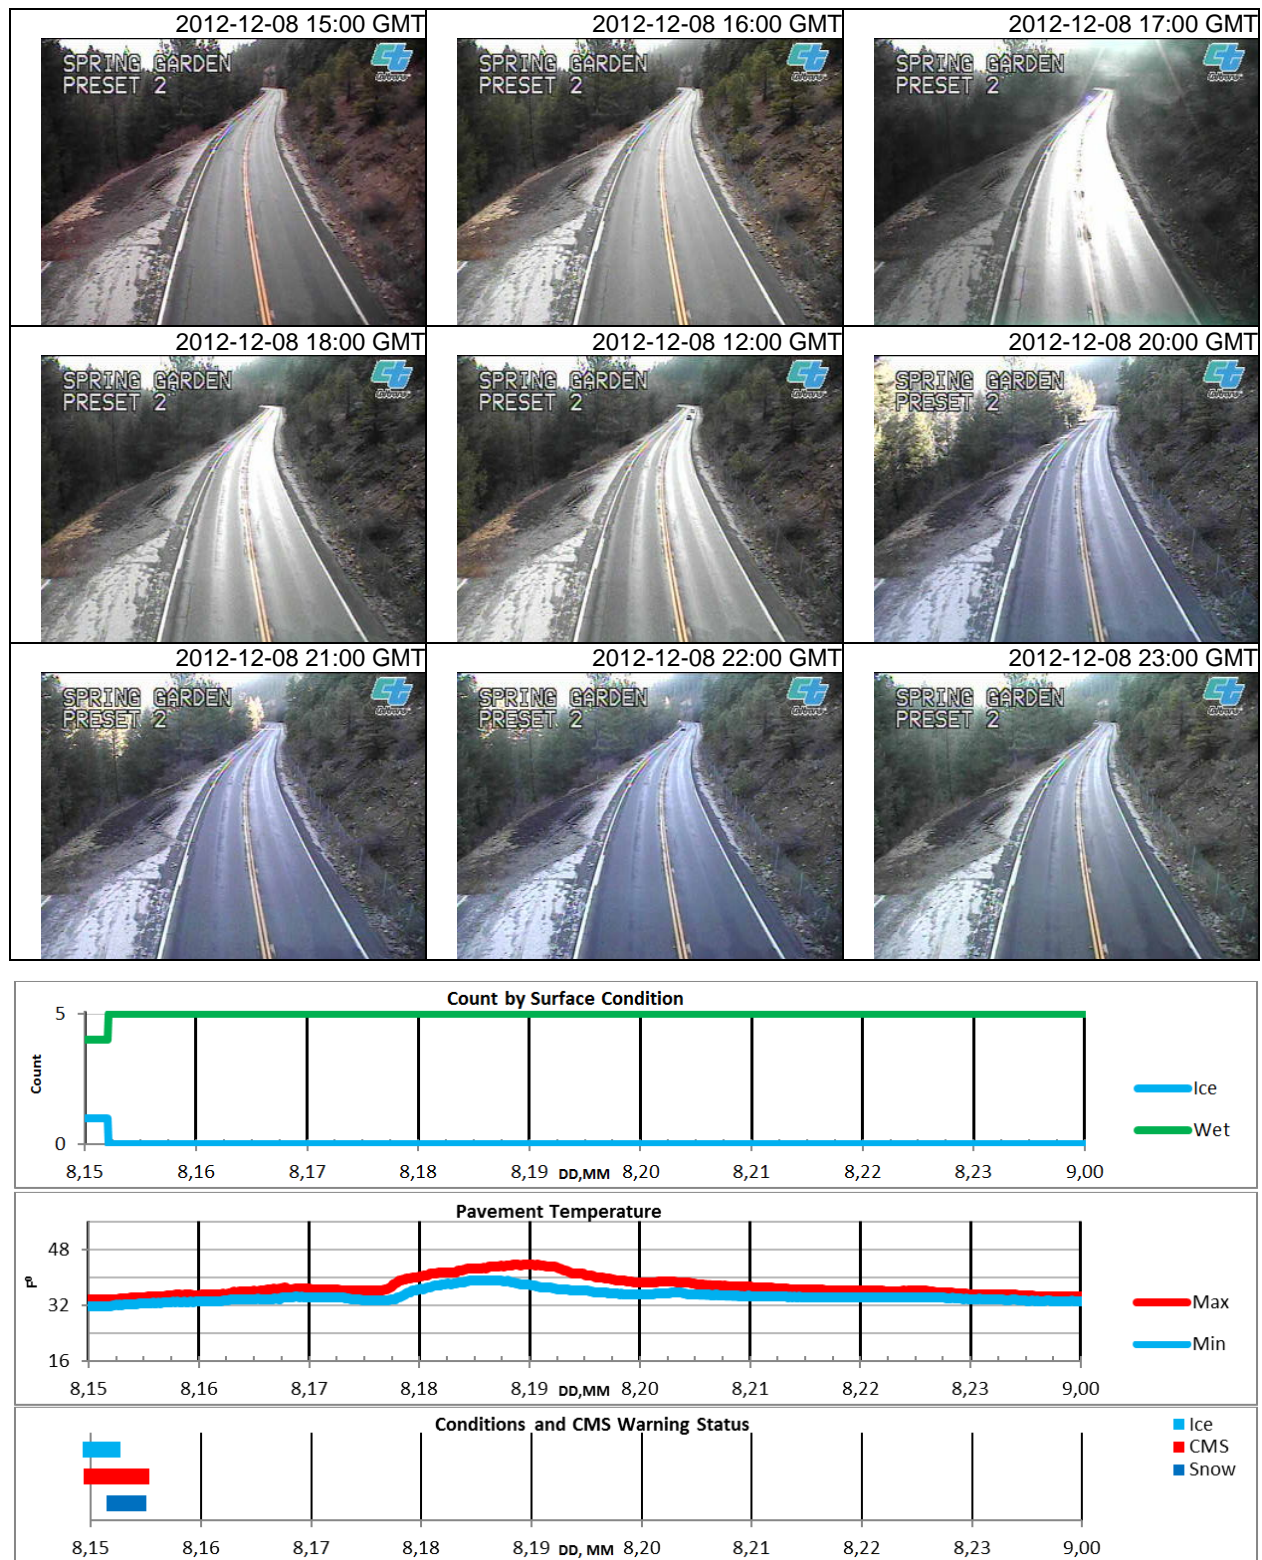
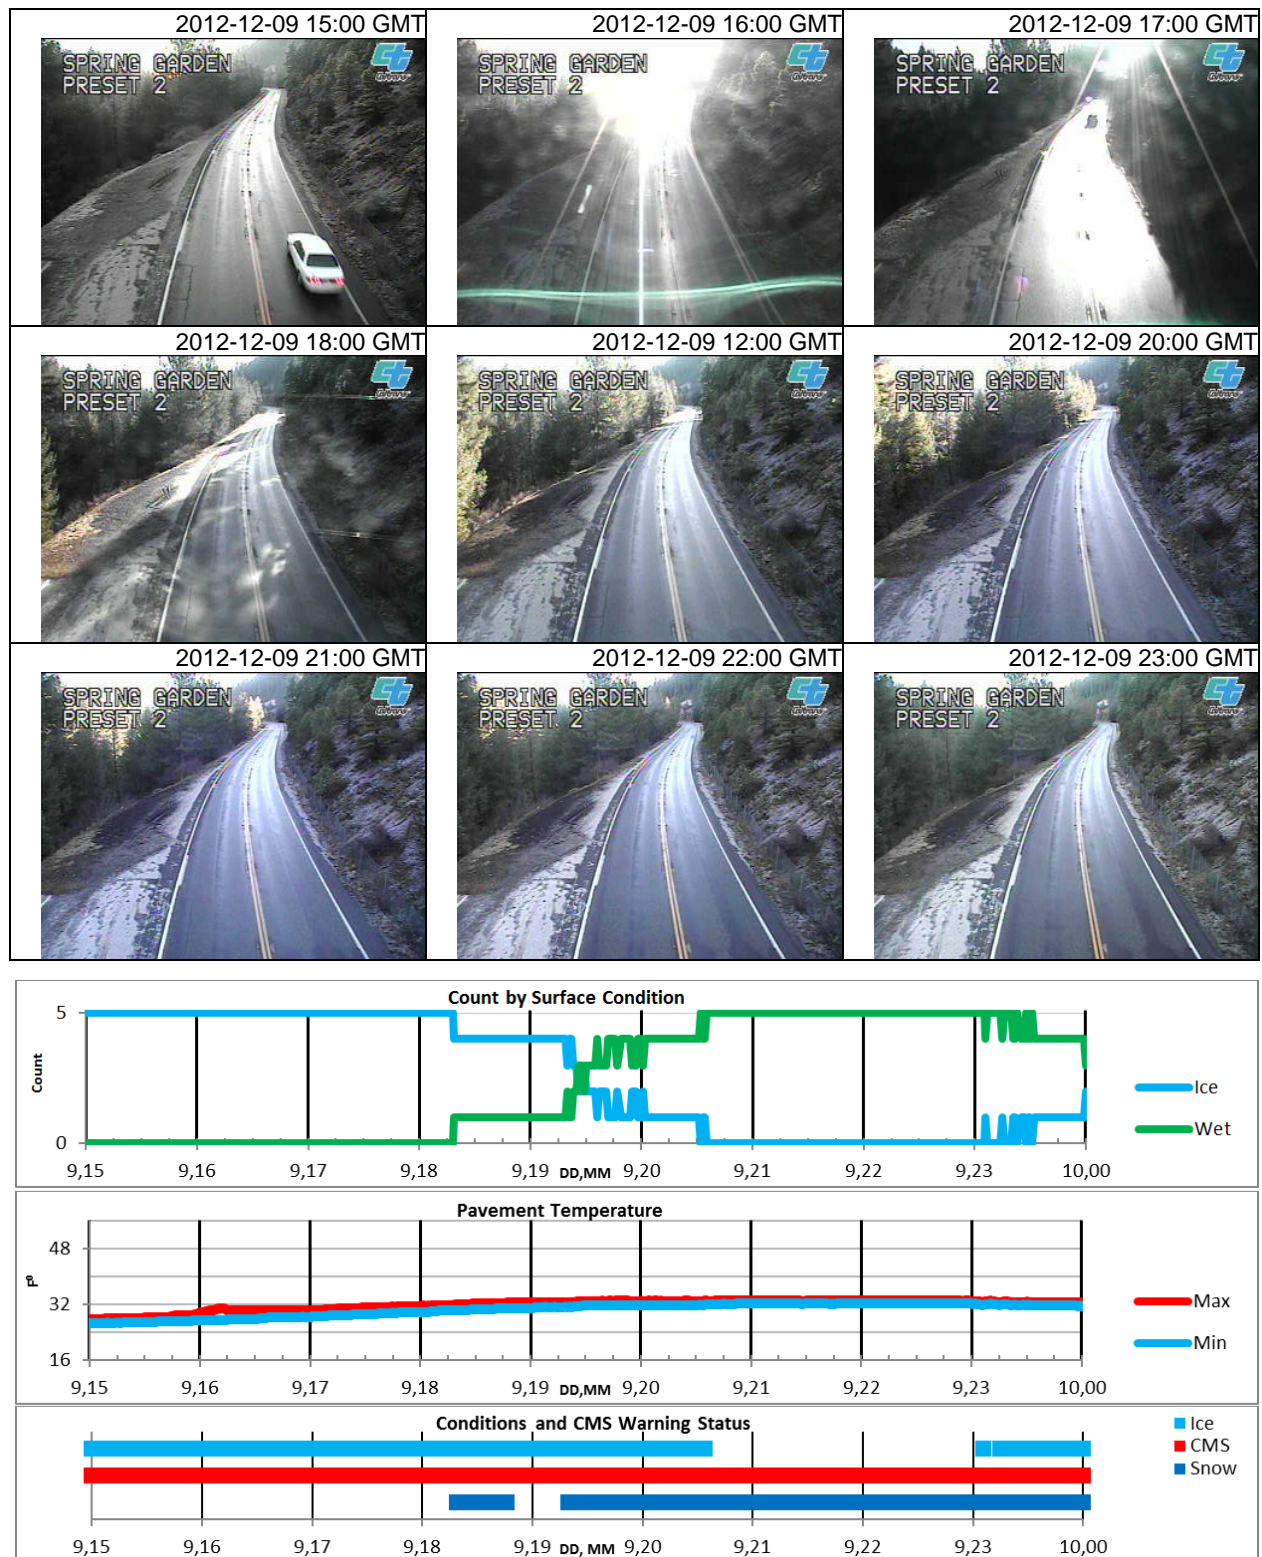
The following CCTV images and graphs corresponding to daylight hours and allow for visual confirmation of the conditions at Spring Garden. Generally the CCTV images confirm the conditions, although it is difficult at times to determine from the images alone whether there is ice on the roadway. It is particularly interesting to observe the times in which conditions were changing from Ice to Wet and versa, including times when there is snow on the road, but ice conditions are not detected. For the latter, the additional logic used by Caltrans District 2 to represent “Snow” conditions appear to be merited, particularly during transition times which might otherwise result in no warning messages.

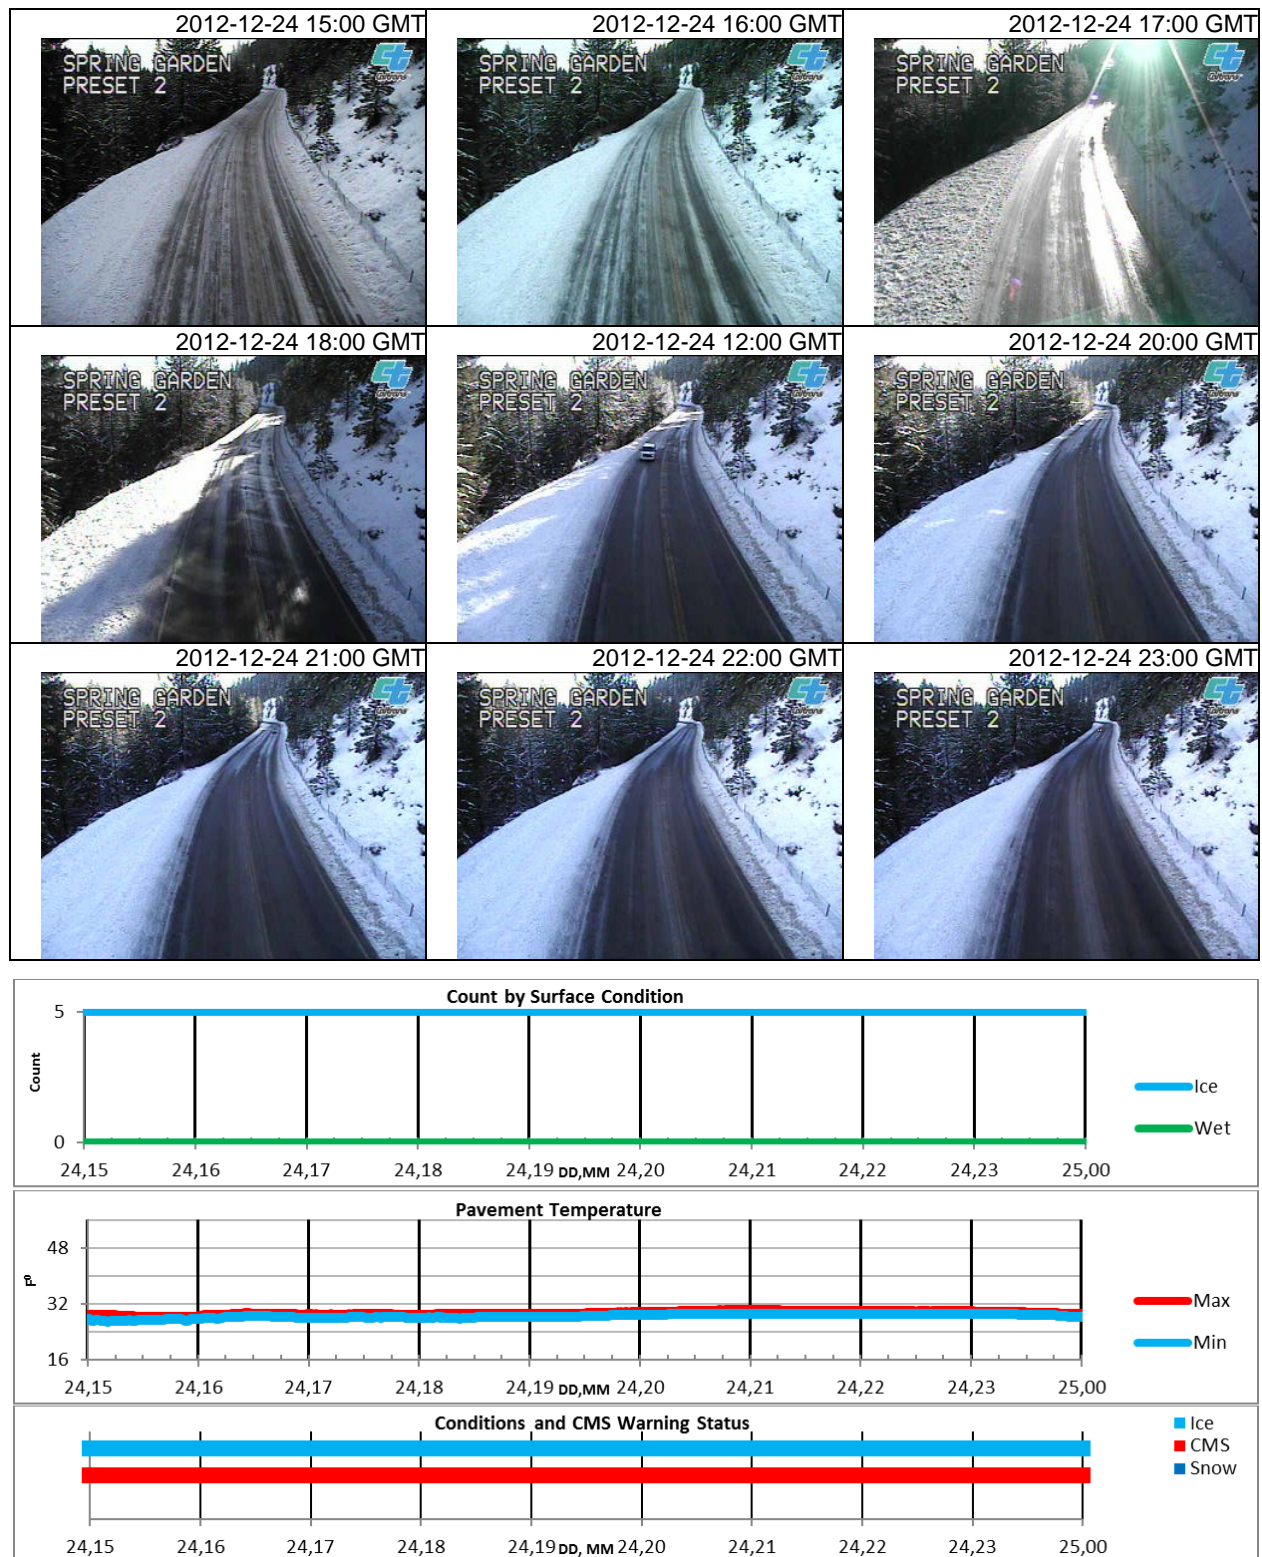
**Figure 42: Conditions and Warning Status for 2012-12-24 GMT (pavement temperatures in °F, “Count” is the number of sensors reporting the given conditions)**

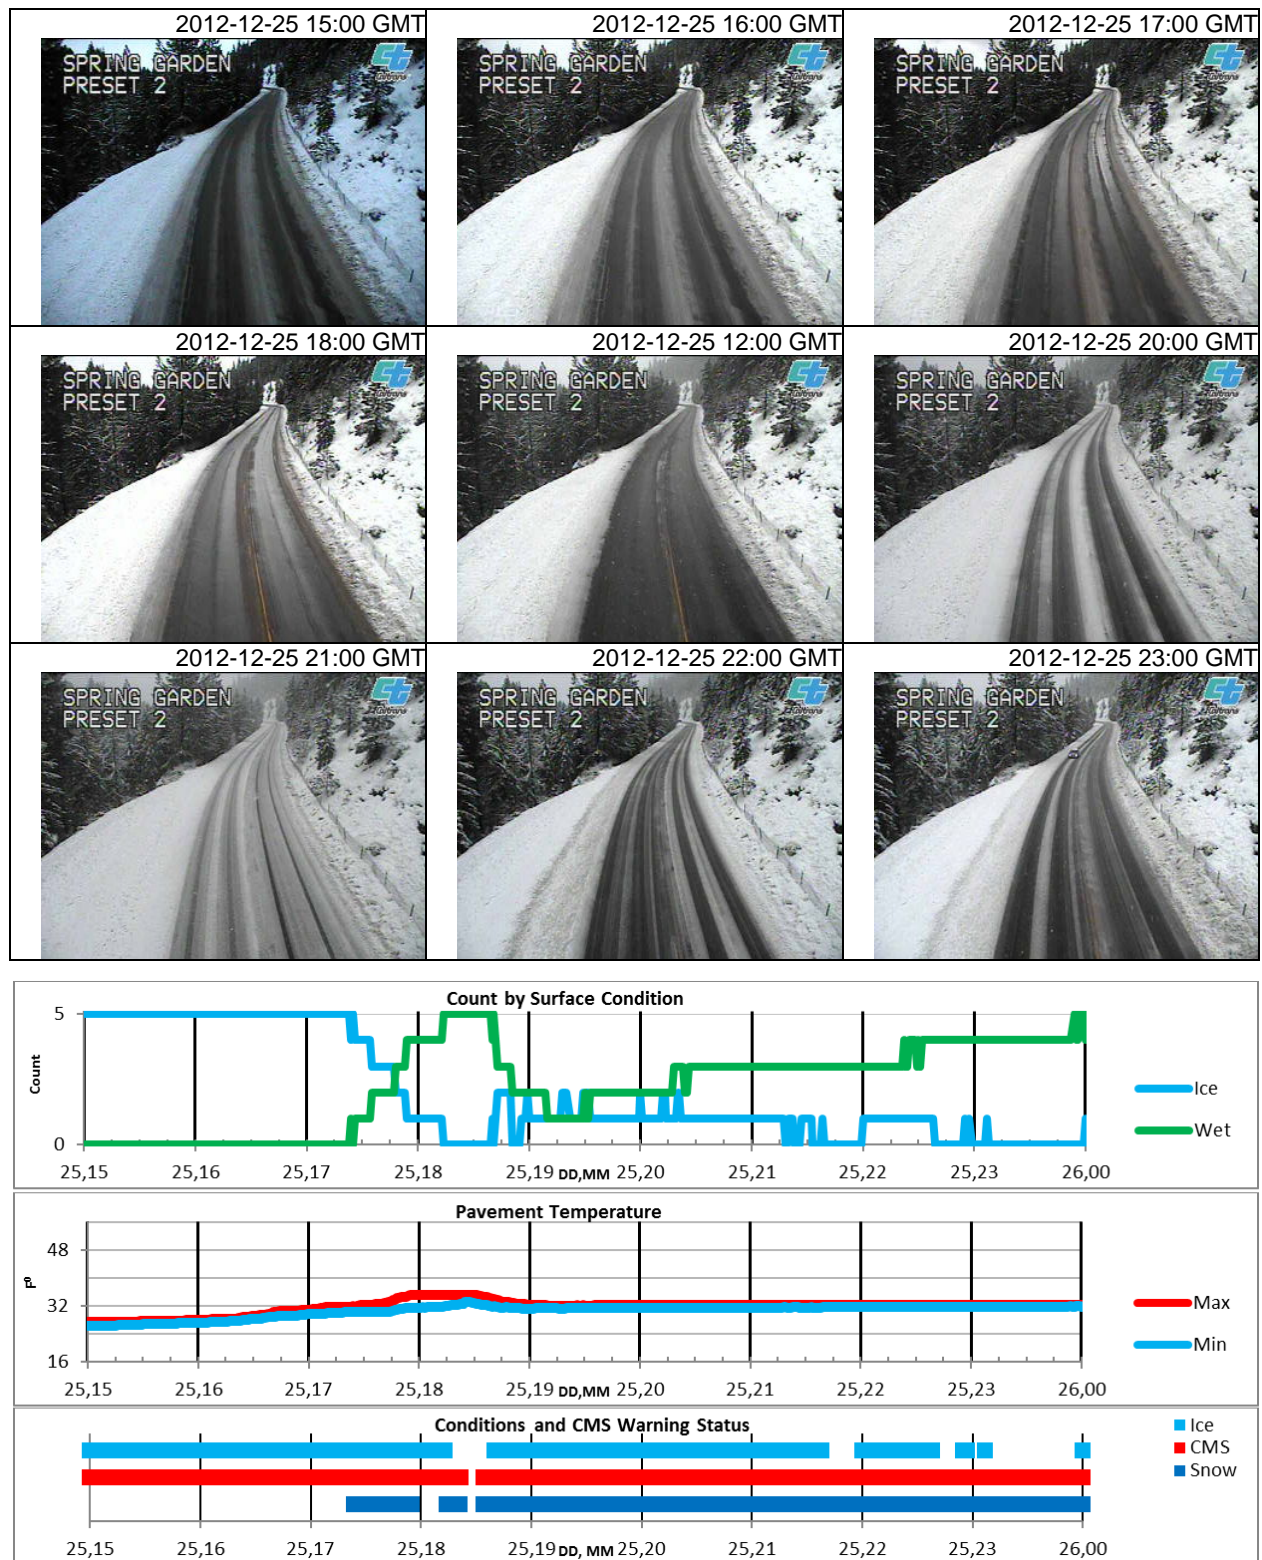
**Figure 43: Conditions and Warning Status for 2012-12-25 GMT (pavement temperatures in °F, “Count” is the number of sensors reporting the given conditions)**
