# **Automated Safety Warning Controller**

## **Final Report**

State of California, Department of Transportation  
Division of Research and Innovation

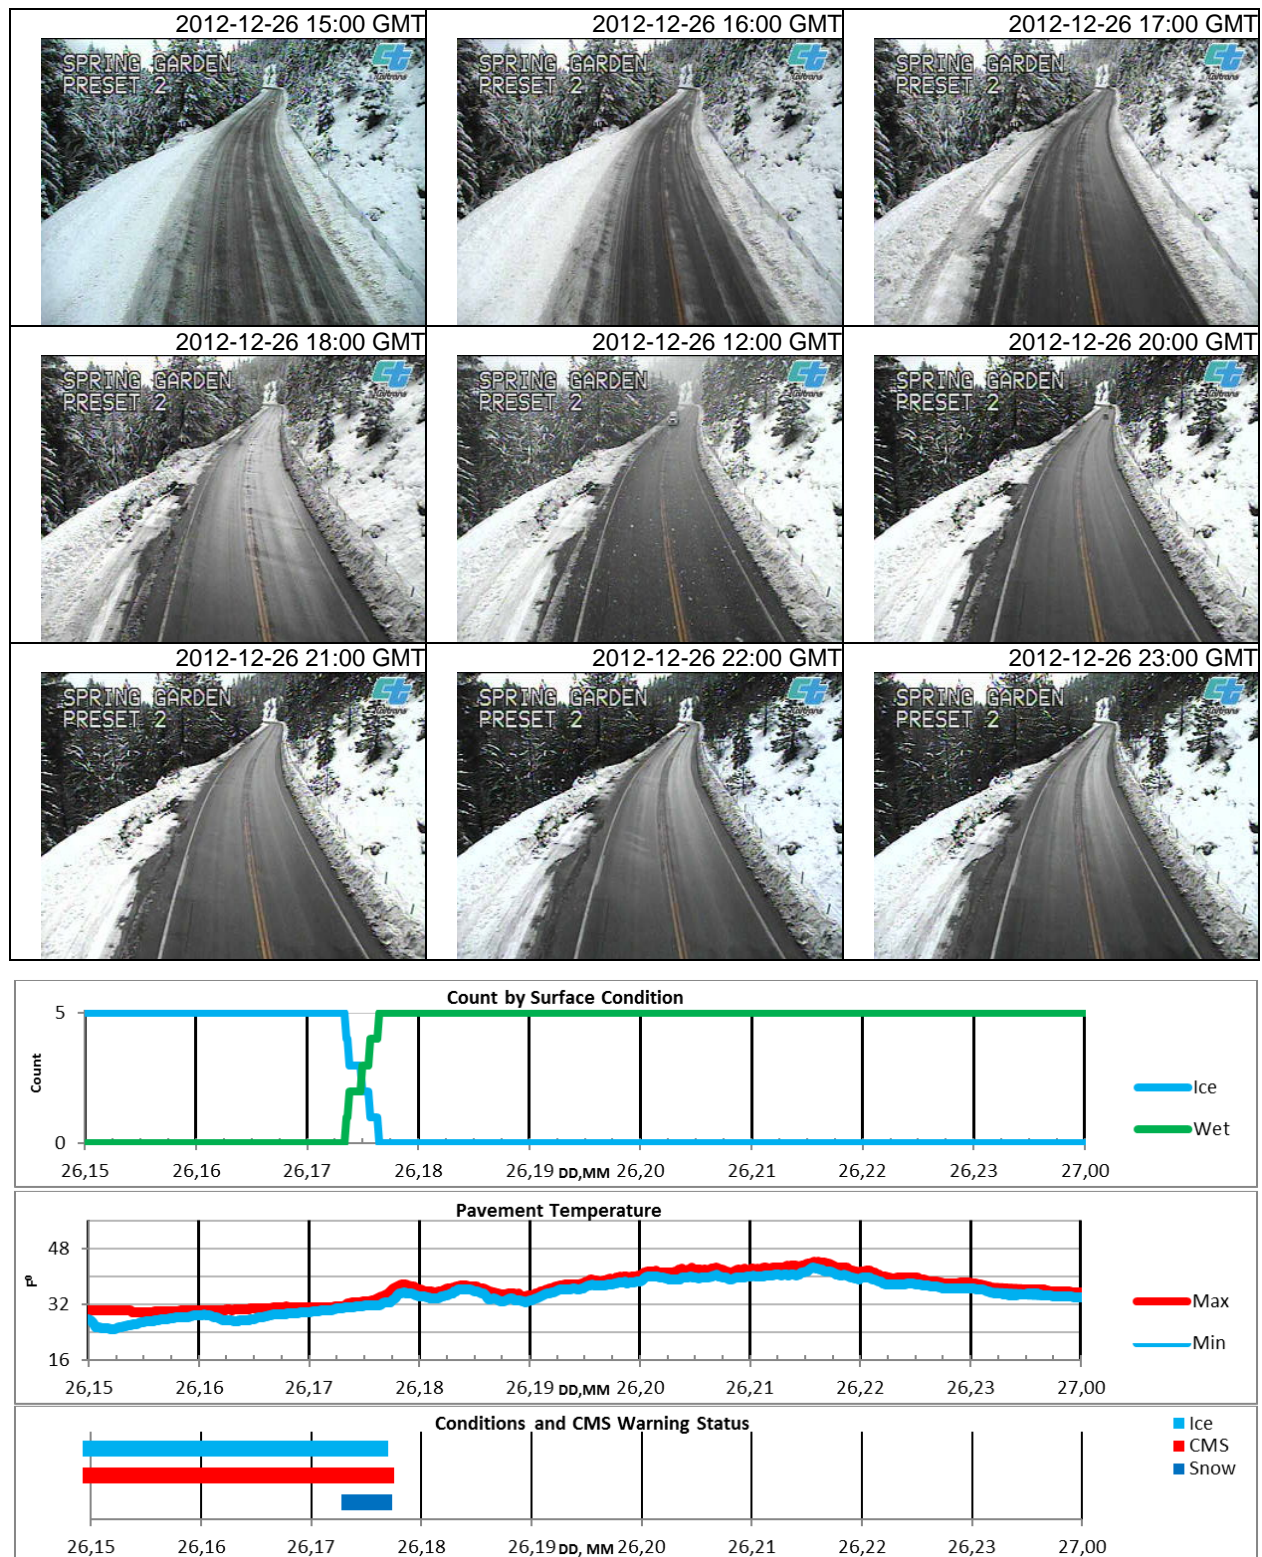
**Figure 44: Conditions and Warning Status for 2012-12-26 GMT (pavement temperatures in °F, “Count” is the number of sensors reporting the given conditions)**

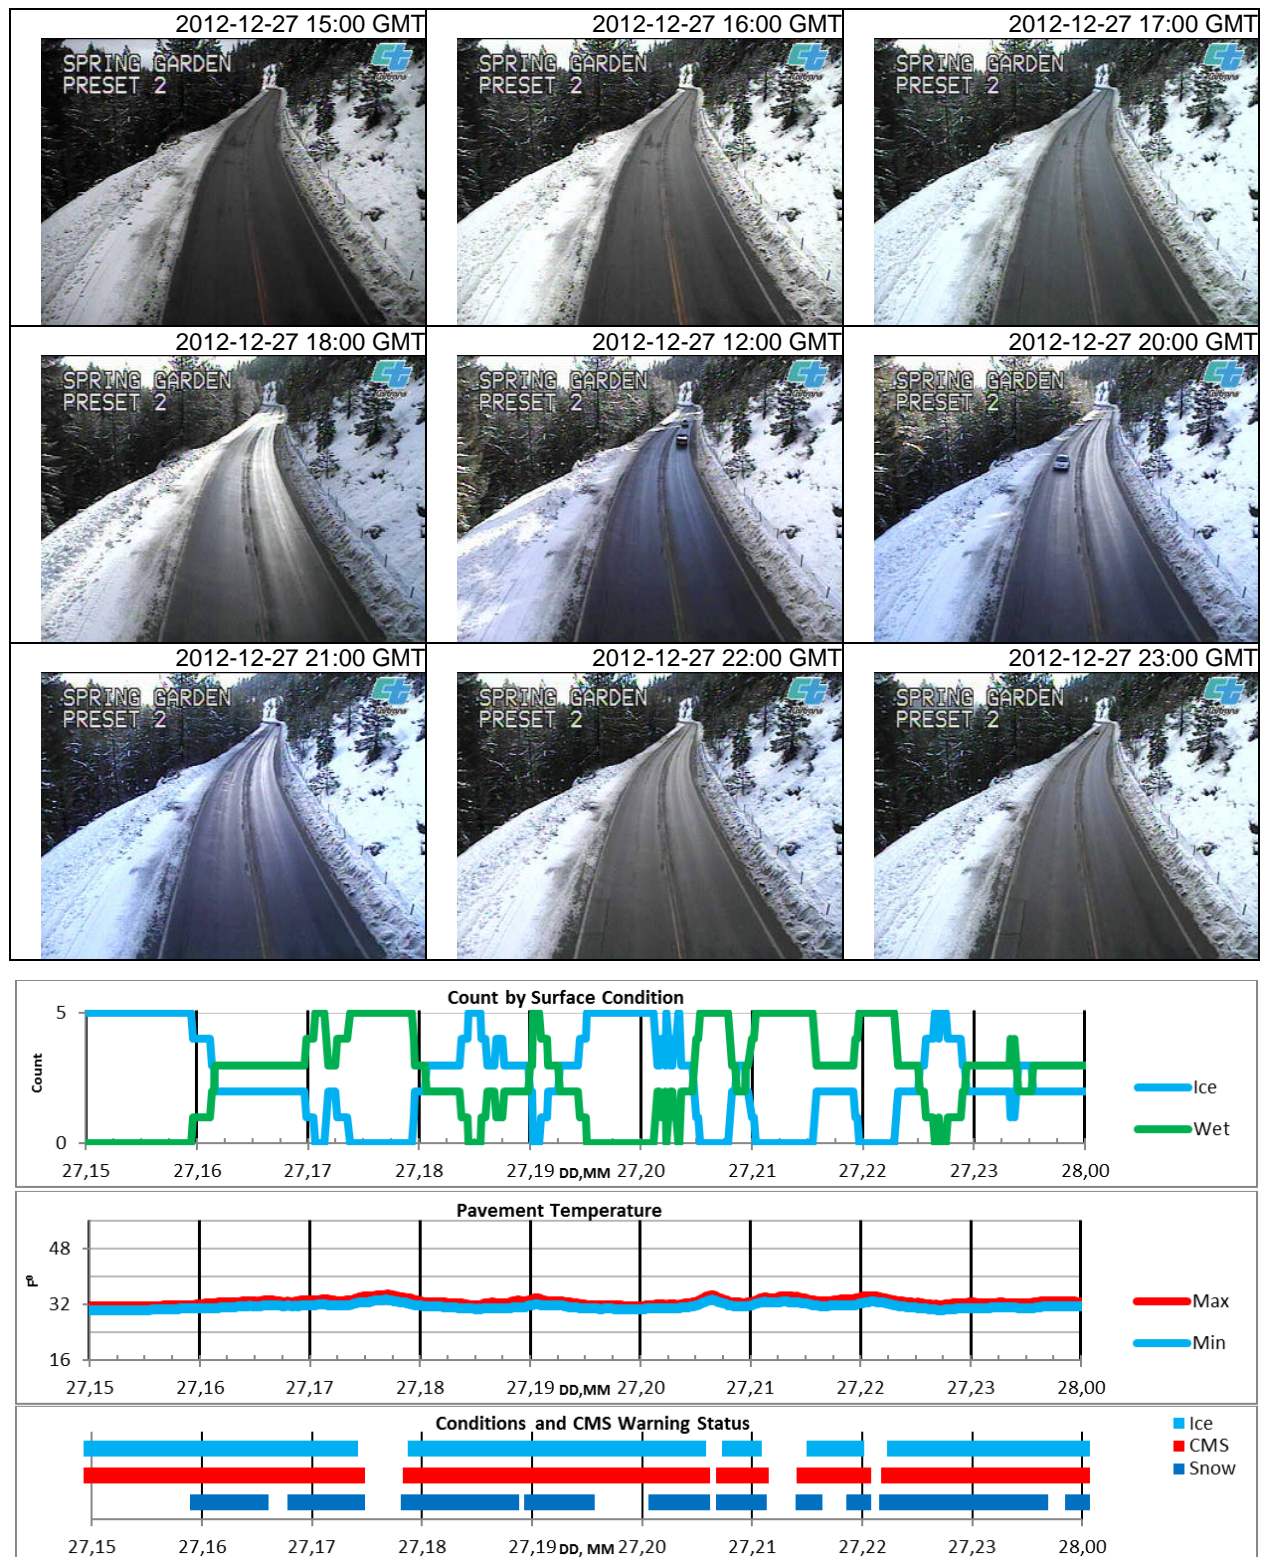
**Figure 45: Conditions and Warning Status for 2012-12-27 GMT (pavement temperatures in °F, “Count” is the number of sensors reporting the given conditions)**

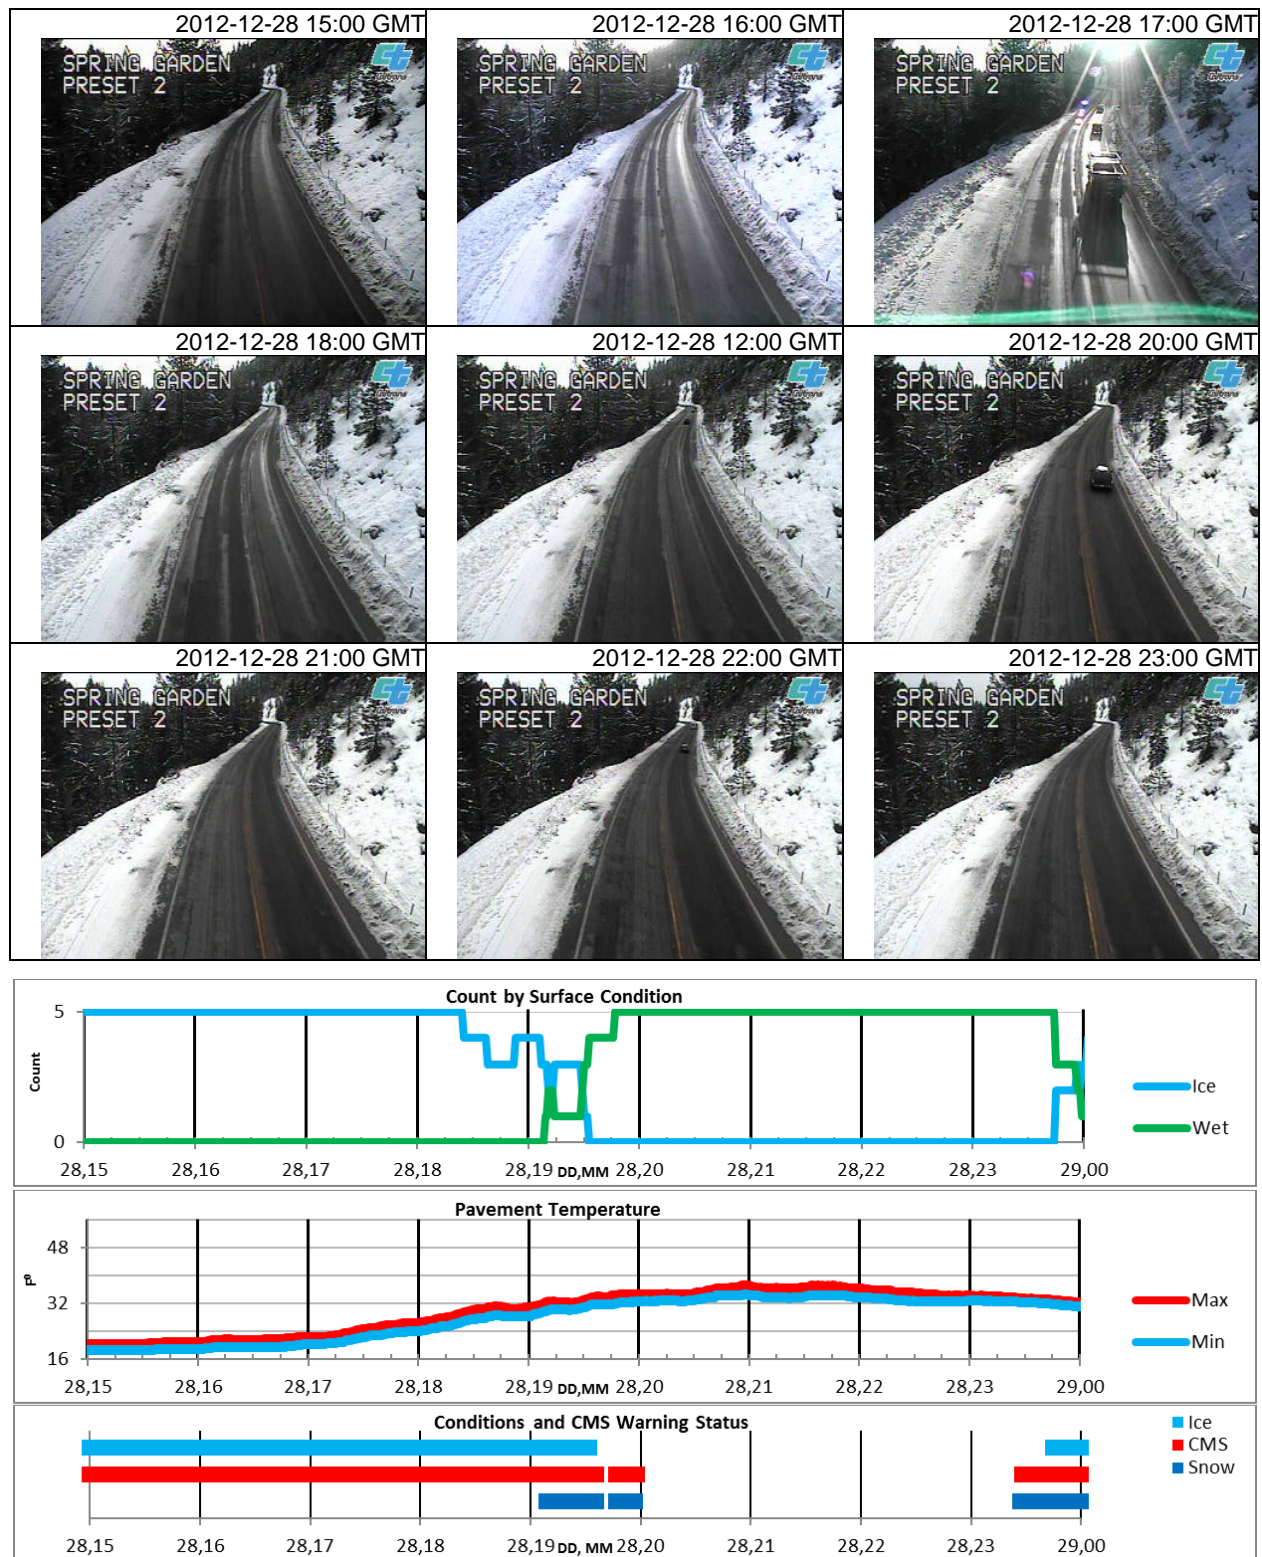
**Figure 46: Conditions and Warning Status for 2012-12-28 GMT (pavement temperatures in °F, “Count” is the number of sensors reporting the given conditions)**

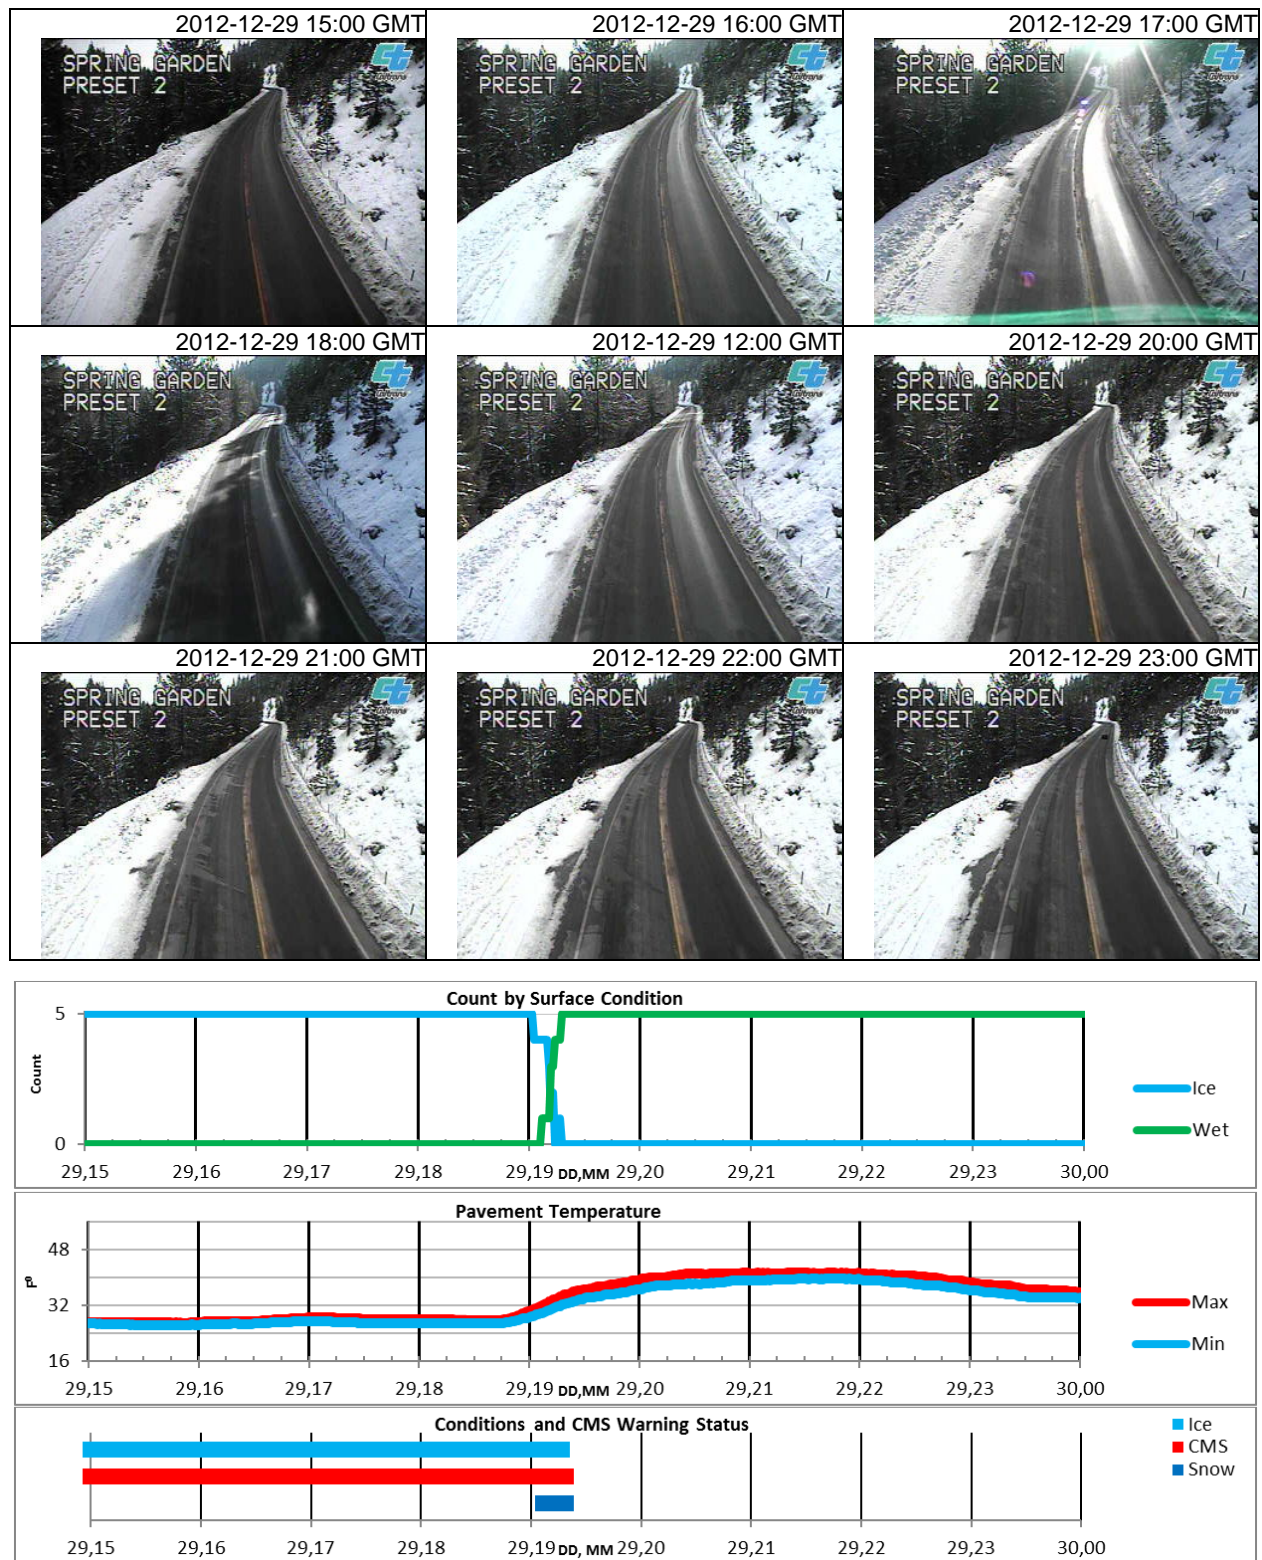
Figure 47: Conditions and Warning Status for 2012-12-29 GMT (pavement temperatures in °F, “Count” is the number of sensors reporting the given conditions)

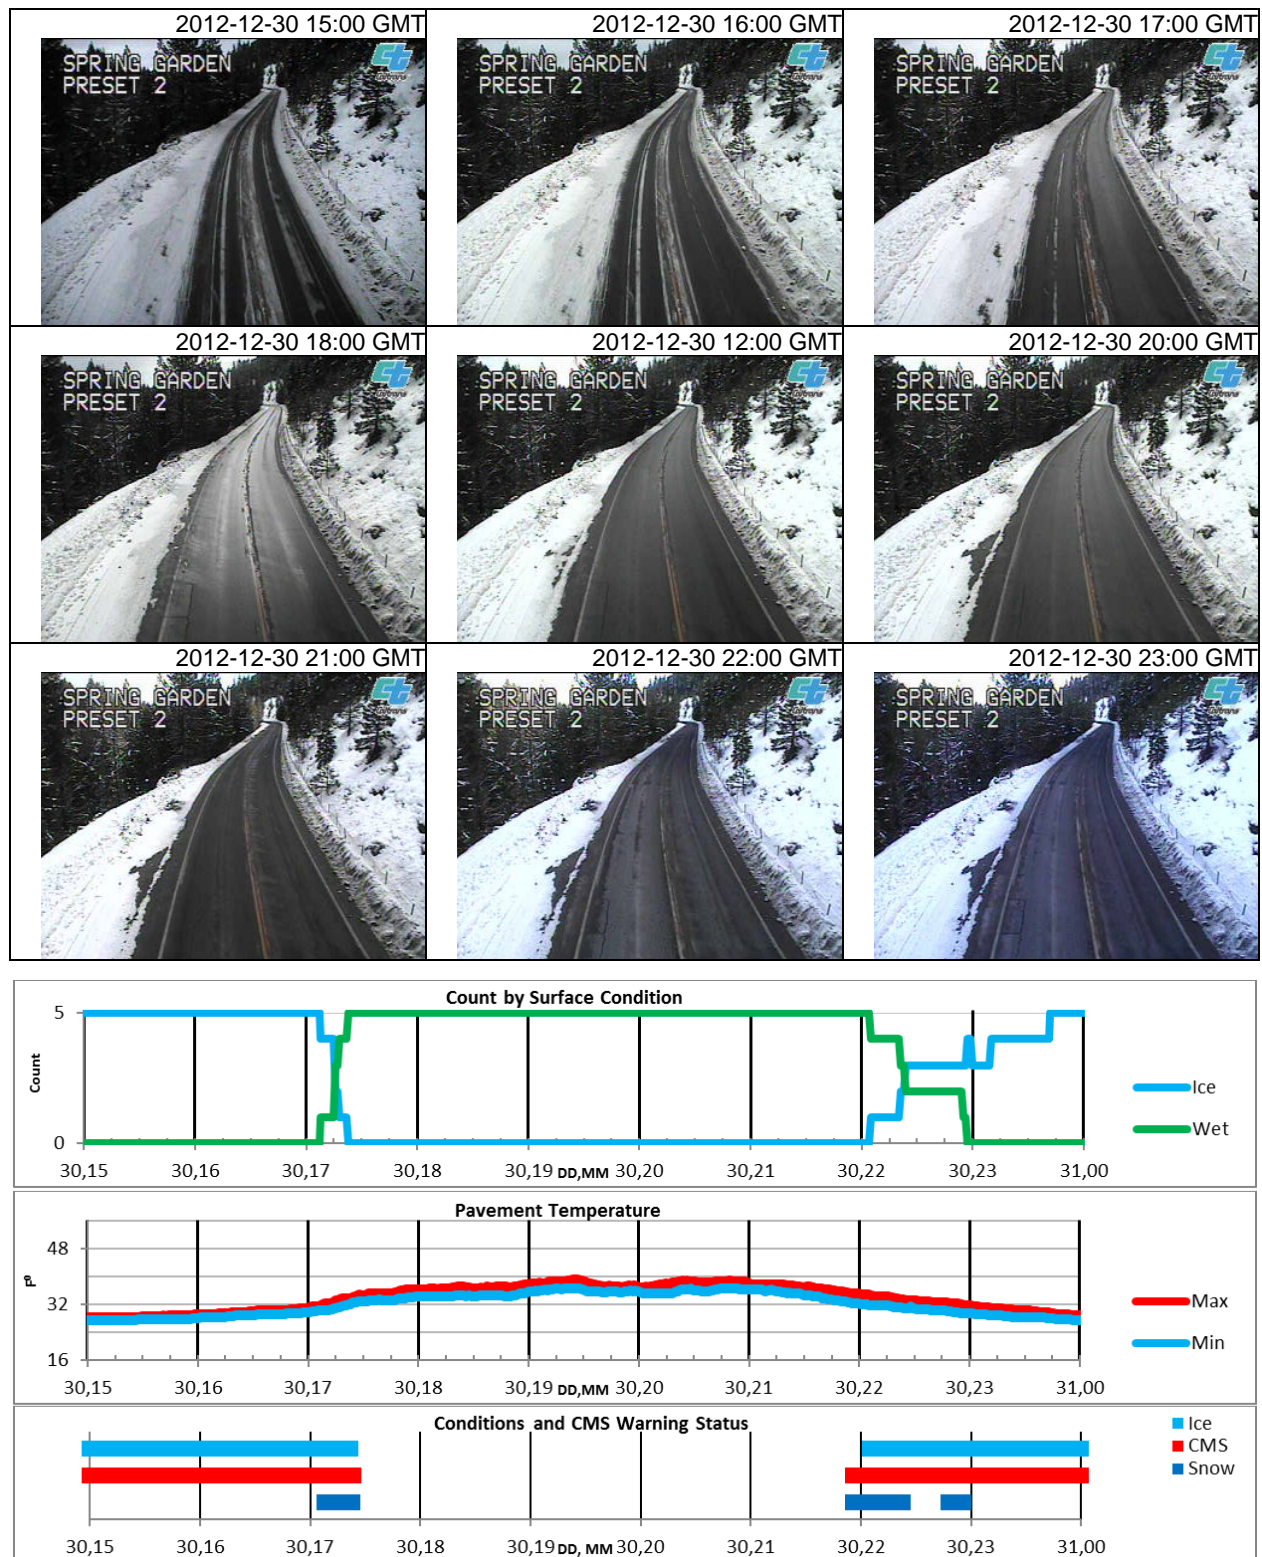
**Figure 48: Conditions and Warning Status for 2012-12-30 GMT (pavement temperatures in °F, “Count” is the number of sensors reporting the given conditions)**

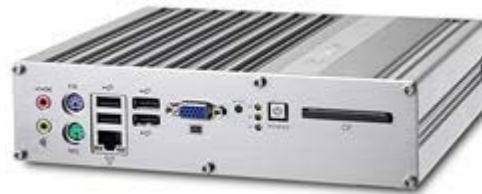
MXE-1005:

- Intel Atom N270 CPU @ 1.6 GHz
- 1 GB RAM
- Fanless
- **No LCD or buttons**
- One 10/100/1000Mbps Ethernet
- Four USB ports
- Two RS-232 serial ports, two RS-232/422/485 serial ports
- One VGA video out port
- CompactFlash slot, SATA port
- No documented installed OS, supports Linux and Windows
- Operating temperature: 14° to 140° F (-10° to 60° C),  
-4° to 158° F (-20° to 70° C) optional
- Price: N/A
- Source: [http://www.adlinktech.com/PD/marketing/Datasheet/MXE-1000Series/MXE-1000Series\\_Datasheet\\_en\\_1.pdf](http://www.adlinktech.com/PD/marketing/Datasheet/MXE-1000Series/MXE-1000Series_Datasheet_en_1.pdf)

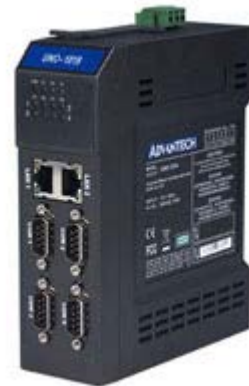
UNO-1019:

- Marvell XScale ARM-5 CPU @ 200 MHz
- 64 MB RAM
- Fanless
- **No LCD or buttons**
- Two 10/100 Mbps Ethernet
- **No USB**
- Two RS-232 serial ports, two RS-232/422/485 serial ports
- No video out port
- CompactFlash slot
- Windows CE 5.0, optional  $\mu$ Clinux
- **Operating temperature: 32° to 158° F (0° to 70° C)**
- Price: \$425.00
- Source: [http://downloadt.advantech.com/ProductFile/Downloadfile4/GF-X1LP/UNO-1019\\_DS.pdf](http://downloadt.advantech.com/ProductFile/Downloadfile4/GF-X1LP/UNO-1019_DS.pdf)

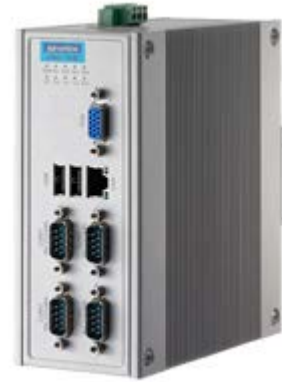
## UNO-1140:

- Advantech 486SX CPU @ 150 MHz
- 64 MB RAM
- Fanless
- **No LCD or buttons**
- One 10/100 Mbps Ethernet
- Two USB ports
- Four RS-232/485 serial ports
- One VGA video out port
- CompactFlash slot
- Optional Windows CE.NET 6.0, DOS, Linux
- Operating temperature: -4° to 167° F (-20° to 75° C)
- Price: \$365
- Source: [http://downloadt.advantech.com/ProductFile/PIS/UNO-1140/Product%20-%20Datasheet/UNO-1140\\_DS20110706140617.pdf](http://downloadt.advantech.com/ProductFile/PIS/UNO-1140/Product%20-%20Datasheet/UNO-1140_DS20110706140617.pdf)

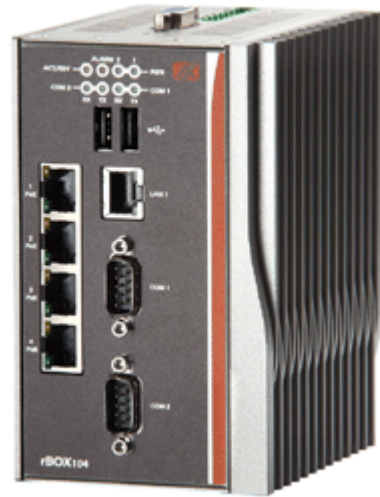
**Axiomtek****rBox104:**

- Intel Atom CPU @ 1.1 GHz
- Up to 2 GB RAM
- Fanless
- **No LCD or buttons**
- One 10/100/1000 Mbps Ethernet
- Two USB ports
- Two RS-232/422/485 serial ports
- One VGA out port
- CompactFlash slot, optional SD card slot
- Two watchdog timers, alarm contact, user defined alarm LED
- Supports WinCE, Linux, Windows® 7
- Operating Temperature: -40° to 158° F (-40° to 70° C)
- Price: N/A
- Source: <http://us.axiomtek.com/Download/Spec/rbox104.pdf>

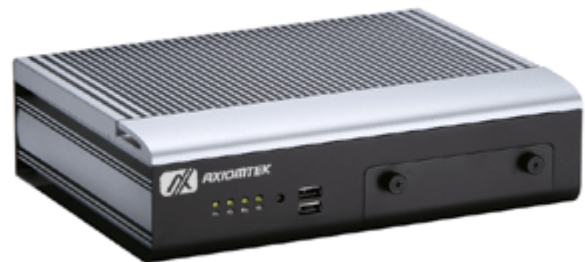
**tBox311-820-FL:**

- Intel Atom CPU @ 1.1 GHz
- Up to 2 GB RAM
- Fanless
- **No LCD or buttons**
- Two 10/100/1000 Mbps Ethernet
- Four USB ports
- No serial ports
- Two VGA video out ports
- One SATA drive bay, one CompactFlash slot
- Watchdog timer, 4 programmable LEDs
- Supports WinCE, Linux
- Operating Temperature: -40° to 149° F (-40° to 65° C)
- Price: N/A
- Source: <http://us.axiomtek.com/Download/Spec/tbox311-820-fl.pdf>

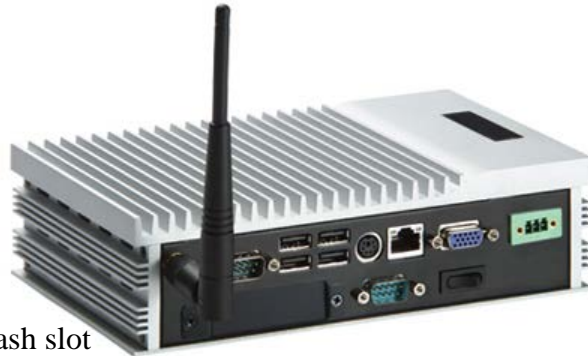
**BSI****EMS6503:**

- Intel Atom @ 1.1 GHz
- Up to 2 GB RAM
- Fanless
- **No LCD or buttons**
- One 10/100/1000 Mbps Ethernet
- Four USB ports
- Two RS-232 serial ports
- One VGA video out port
- One SATA drive bay, one CompactFlash slot
- Watchdog timer
- Supports Windows XPE
- Operating temperature: -4° to 149° F (-20° to 65° C)
- Price: \$805
- Source:  
[http://www.bsicomputer.com/new/embedded\\_computer/ems6503/ems6503\\_embedded\\_computer.htm](http://www.bsicomputer.com/new/embedded_computer/ems6503/ems6503_embedded_computer.htm)

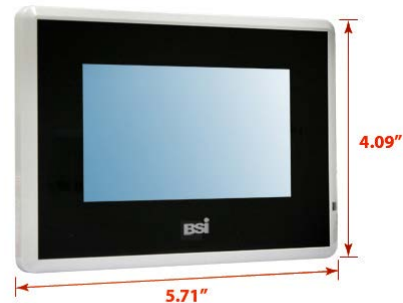
**IOVU-430M:**

- Intel XScale RISC CPU @ 416 MHz
- 128 MB RAM
- Fanless
- Touch sensitive LCD
- One 10/100 Mbps Ethernet
- One USB port
- One RS-232/422/485 serial port
- miniSD card slot
- Windows CE 5.0
- Operating temperature: -4° to 140° F (-20° to 60° C)
- Price: N/A
- Source:  
[http://www.bsicomputer.com/new/panel\\_PC/iovu430m/iovu430m\\_touch\\_panel\\_pc.htm](http://www.bsicomputer.com/new/panel_PC/iovu430m/iovu430m_touch_panel_pc.htm)

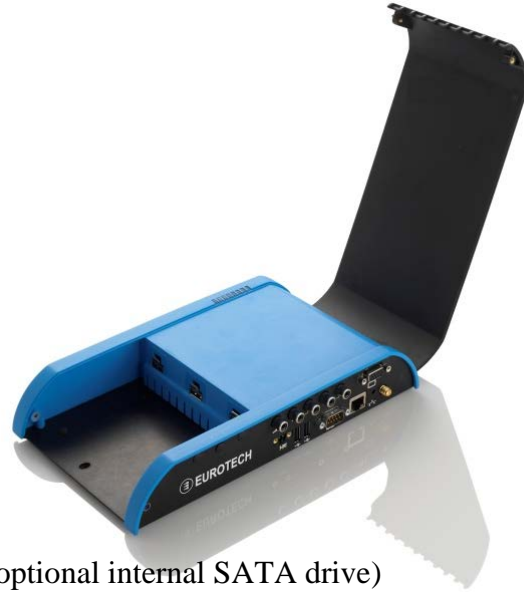
#### Helios:

- Intel Atom @ 1.1 GHz
- 512 MB RAM
- Fanless
- **No LCD or buttons**
- One 10/100/1000 Mbps Ethernet
- Five USB ports (3 inside bay)
- One RS-232/485 serial port
- Optional multimedia card for video out
- 2 GB CompactFlash card (optional SD card, optional internal SATA drive)
- Eight programmable LEDs, one software readable push button
- Wind River Linux 3.0, Windows CE 6.0
- Operating temperature: -40° to 185° F (-40° to 85° C)
- Price: N/A
- Source:  
[http://www.eurotech.com/DLA/datasheets/Products\\_Eurotech/HeliosPlatform\\_sf.pdf](http://www.eurotech.com/DLA/datasheets/Products_Eurotech/HeliosPlatform_sf.pdf)

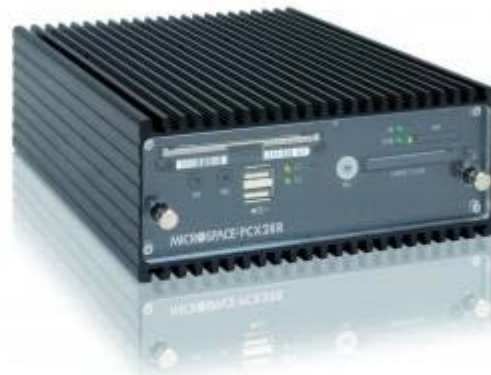
#### MICROSPACE MPCX28R:

- Intel Atom CPU @ 1.6 GHz
- 1 GB RAM
- Fanless
- **No LCD or buttons**
- Two 10/100 Mbps Ethernet
- Five USB ports
- Two RS-232/422/485 serial ports
- One DVI video out port, VGA optional
- One SATA bay, optional CompactFlash
- Compatible with Windows or Linux
- Operating temperature: -4° to 158° F (-25° to 70° C)
- Price: N/A
- Source:  
<http://us.kontron.com/etc/scripts/download/getdownload.php?downloadId=MTEzNDY=>

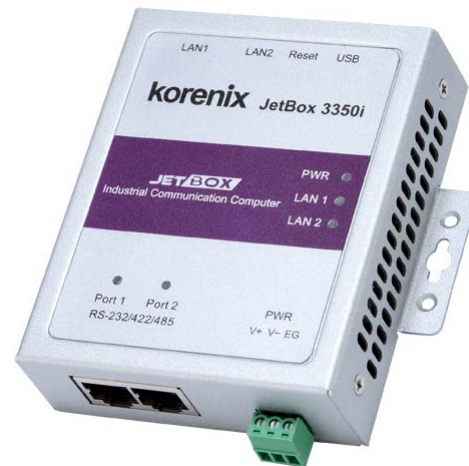
**Korenix****JetBox 3350i-w:**

- Atmel ARM CPU @ 180 MHz
- 64 MB RAM
- Fanless
- **No LCD or buttons**
- Two 10/100 Mbps Ethernet
- Two USB ports
- Two RS-232/422/485 serial ports
- No video out port
- One microSD slot
- Watchdog timer
- Linux
- Operating temperature: -40° to 176° F (-40° to 80° C)
- Price: N/A
- Source: <http://www.korenix-usa.com/pdfs/JetBox3350i-w-low.pdf>

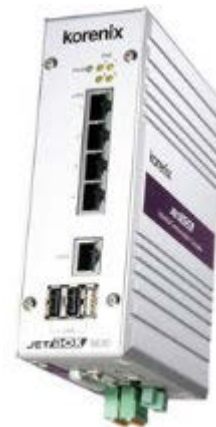
**JetBox 9430-w:**

- Intel XScale IXP435 RISC CPU @ 667 MHz
- 128 MB RAM
- Fanless
- **No LCD or buttons**
- Five 10/100 Mbps Ethernet
- Three USB ports
- No serial ports
- No video out port
- One SD card slot, one CompactFlash card slot
- Watchdog timer
- Linux 2.6.20
- Operating temperature: -40° to 176° F (-40° to 80° C)
- Price: N/A
- Source: <http://www.korenix-usa.com/pdfs/JetBox9430-w-low.pdf>

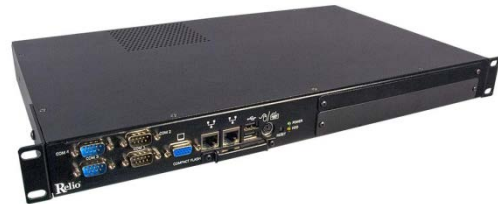
## Relio R4300:

- AMD Geode CPU @ 500 MHz
- 1 GB RAM
- Fanless
- **No LCD or buttons**
- Two 10/100 Mbps Ethernet
- Two USB ports
- Two RS-232/422/485 serial ports, two RS-232 serial ports
- One VGA video out port
- One optional internal hard drive, one CompactFlash slot
- Watchdog timer
- Windows and Linux compatible
- Operating temperature: **32° to 122° F (0° - 50° C)** (Extended temperature options available)
- Price: \$999
- Source: <http://www.sealevel.com/store/computing-hmi/industrial-computers/expandable-rackmount/r4300-relio-r4300-500mhz-amd-geode-lx800.html>

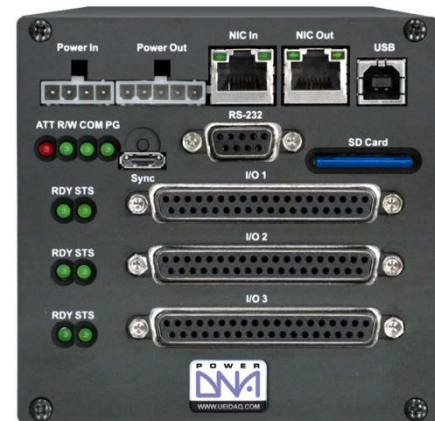
**United Electronic Industries****DNA-PPCx:**

- Freescale MPC5200 CPU @ 400 MHz
- 128 MB RAM
- Fanless
- **No LCD or buttons**
- Two 10/100 Mbps Ethernet
- **No USB host ports**
- One RS-232 serial port
- No video out port
- 128 MB internal flash, SD card slot
- Windows and Linux compatible
- Operating temperature: -40° to 185° F (-40° to 85° C)
- Price: \$995
- Source: <http://www.ueidaq.com/media/catalog/product/pdf/datasheet/dna-ppcx.pdf>

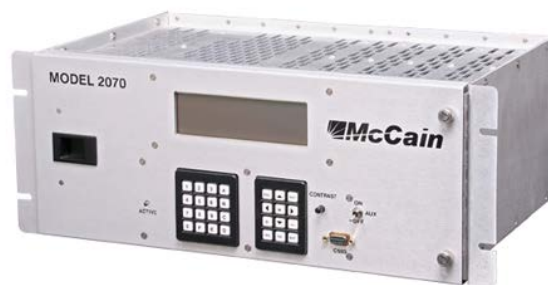
**Environment:** Operating Temperature:  $-37^{\circ}\text{C}$  to  $+74^{\circ}\text{C}$   
Humidity: 0 to 95% (non-condensing)

- 256MB DDR memory expansion
- Optional modules
- Various modems (2070 form factor)
- GPS module

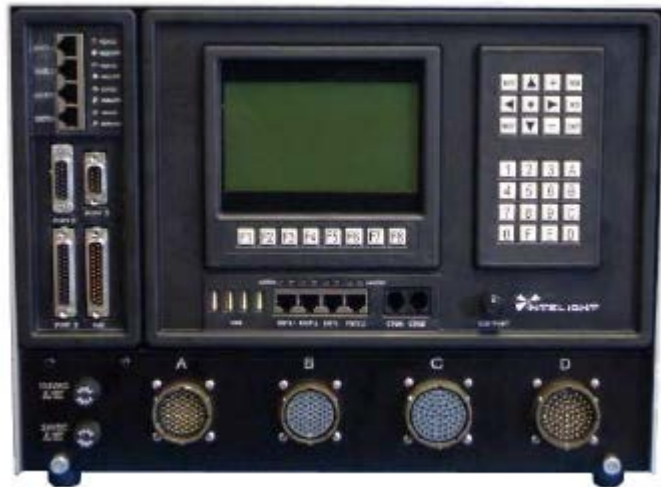
**Intelight****NEMA TS2 Type 1 & 2 Advanced Transportation Controller (ATC)**

- Compliant with current NEMA TS2 and ATC 5.2b standards
- Open Architecture Embedded Linux Multi-Processing Operating System
- 4 Standard 10/100 Mbit Ethernet Ports
- 2 Quad 4 Port Integral Ethernet Switches
- 4 USB Ports
- 2 Keypads & 8 Programmable Special Function Keys
- ATC 5.2b Compliant Engine Board CPU
- ATC Standard API for third party application support
- Two ATC/2070 Type Communications/Modem Slots
- 16 Line X 40 Character (240 X 120 Graphics) LCD Display
- 7 configurable Serial Ports (5 are SDLC capable)
- 14 3/4" W X 7 3/4" D X 10 1/2" H
- Power 95 - 250 VAC 50/60 Hz Auto Sensing
- -40 to +80° C operating environment
- 64MB Flash / 64MB DRAM memory / 1MB SRAM

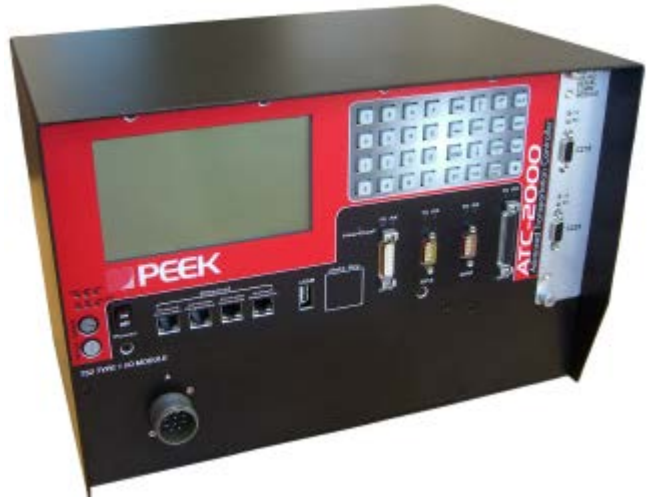
**Transportation Control Systems****ATC-2000 Transportation Controller**

- 16MB SDRAM memory (standard)
- 32MB and 64MB available as upgrade options
- 1MB SRAM
- Dimensions: 14¾" Wide × 10½" Deep × 10¼" Tall (375mm × 267mm × 261mm)

- Power requirements 95 to 135VAC 60Hz ± 3 Hz
- Environment: -35°F to + 165°F -37°C to + 74°C
- 0-95% relative humidity

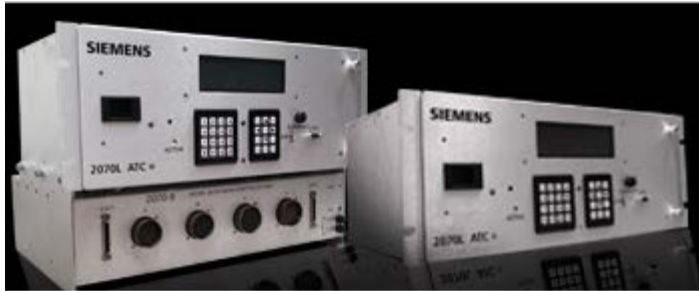
- Multitasking - each 2070ATC unit can control multiple applications
- Multiprocessing - each 2070ATC unit can accommodate multiple CPUs
- High speed serial communications to CPU

- Designed and built for unattended operation in harsh environments
- Built-in 10 Base-T Ethernet with IP address on 2070-1B (2070L models)

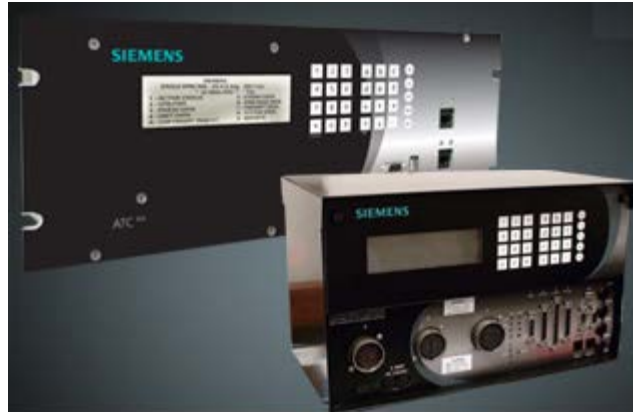
**SITRAFFIC® Sphere ATC**

Freescall Power Quicc II Pro microprocessor w/ e200 core, running at 500MIPs with E200 core 266 MHz processor

- 36MB flash memory
- 64 MB DRAM
- 2 MB SRAM
- Linux operating system using glibc w/ C++ support libraries
- Multi-line alpha-numeric backlit display
- Durable front coating
- Runs multiple-concurrent applications
- Lightweight, injection molded, high-impact poly-carbonate case (rack mount)
