Weather Warning Systems in Oregon

Doug Spencer, PE
Standards Engineer
Intelligent Transportation Systems

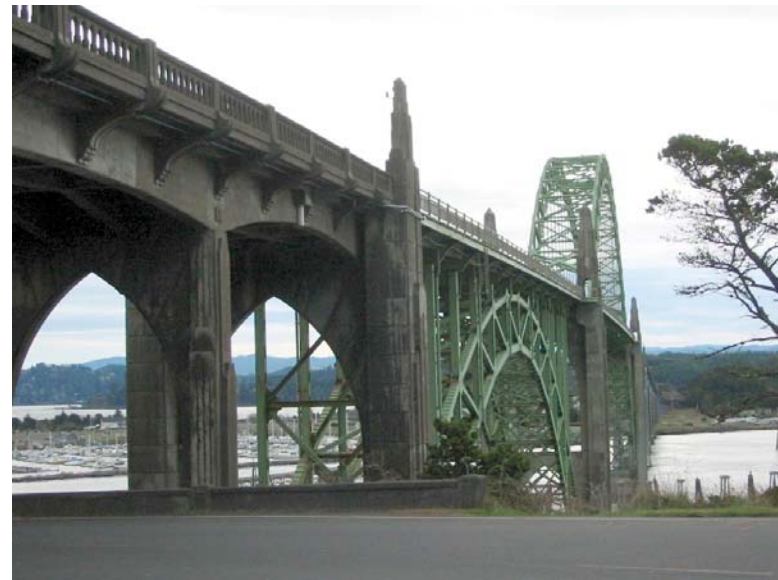
Equipment at Yaquina Bay/Newport

■ Main Panel

- RM Young Anemometer with (4-20mA) transmitter
- Opto22 Ultimate I/O PLC
- RTD 3 wire temperature sensor
- Existing leased T1 circuit
- Existing camera
- 12V DC power supply
- UL 508A panel assembly
- Surge protection
- Heater
- 316 SST UL 50 Type 4X panel

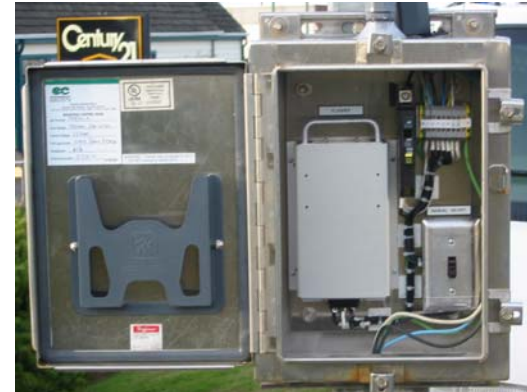
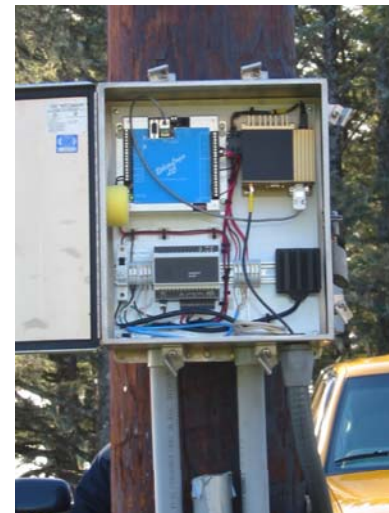
Radio and Flasher Cabinets

■ Equipment

- Radio – Dataradio Integra TR
FCC licensed 132-174 MHz
- 2 I/O Devices by Wireless Group
- NEMA Flasher
- UL 508A panels

■ Installation

- UL Panel Shop
- Wireless Group
- ODOT Electricians

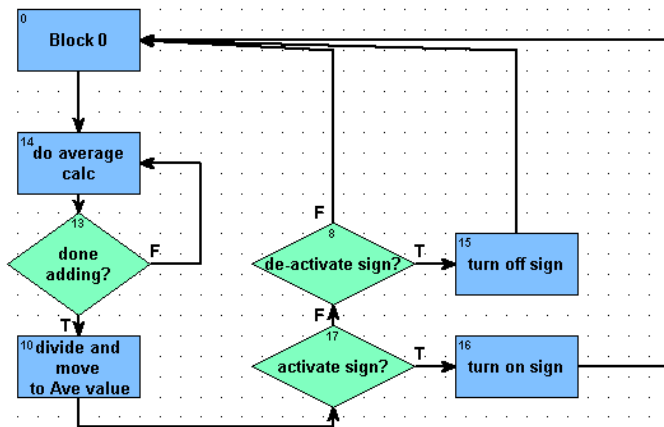
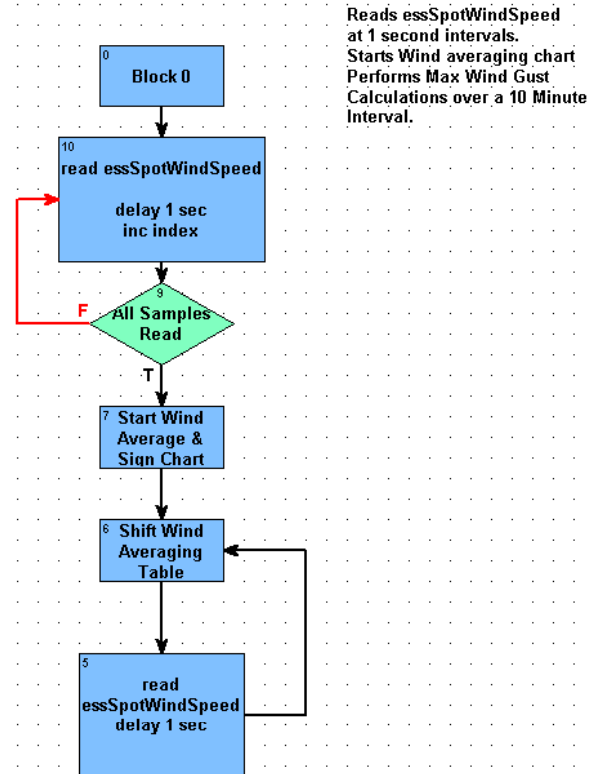
Yaquina Bay Opto22 PLC program

Wind Averaging Calculations
&
Sign Activation Control
Chart activated after 120
1 second readings are
obtained in the
Windspeed_Gust Chart

Reads essSpotWindSpeed
at 1 second intervals.
Starts Wind averaging chart
Performs Max Wind Gust
Calculations over a 10 Minute
Interval.

- Maximum Gust, Avg. Speed, Avg. Direction defined from NTCIP 1204 Environmental Sensor Station Interface Standard
- Signs ON at 35 mph average speed or greater
- Signs OFF at 25 mph average speed or less
- Contact closures between PLC and radio systems due to organizational issues

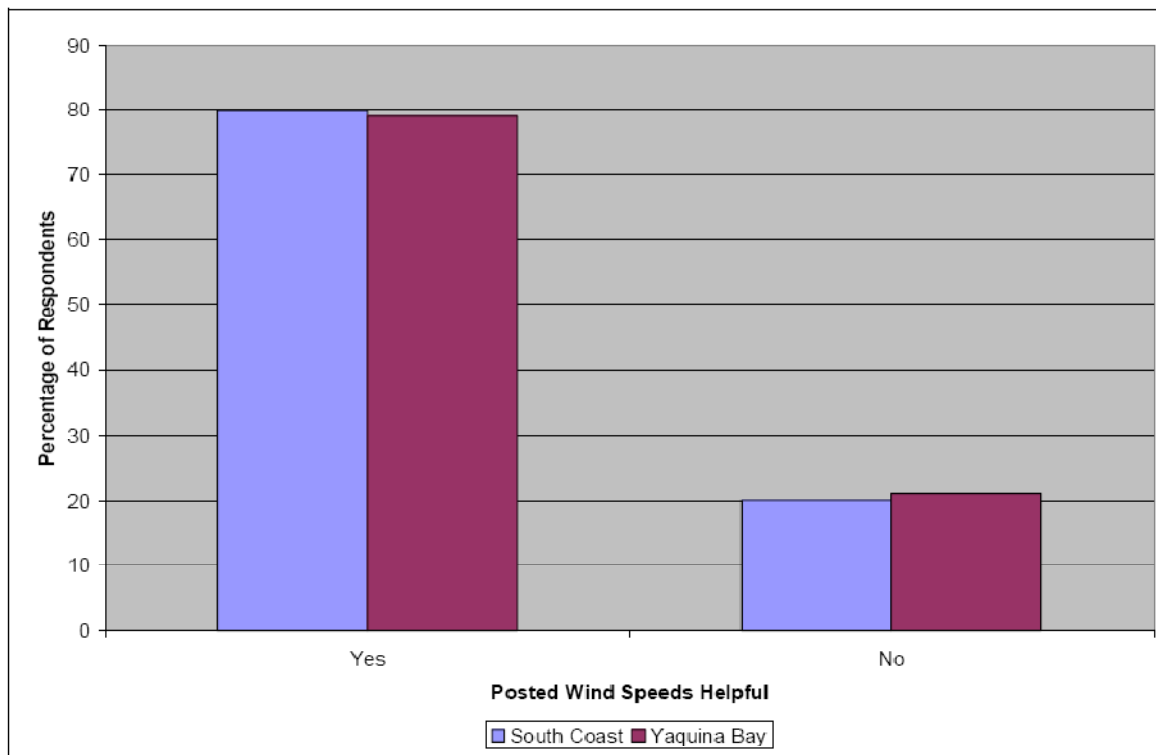
Figure 7-4. Helpfulness of Posting Wind Speeds

Helpfulness to motorists

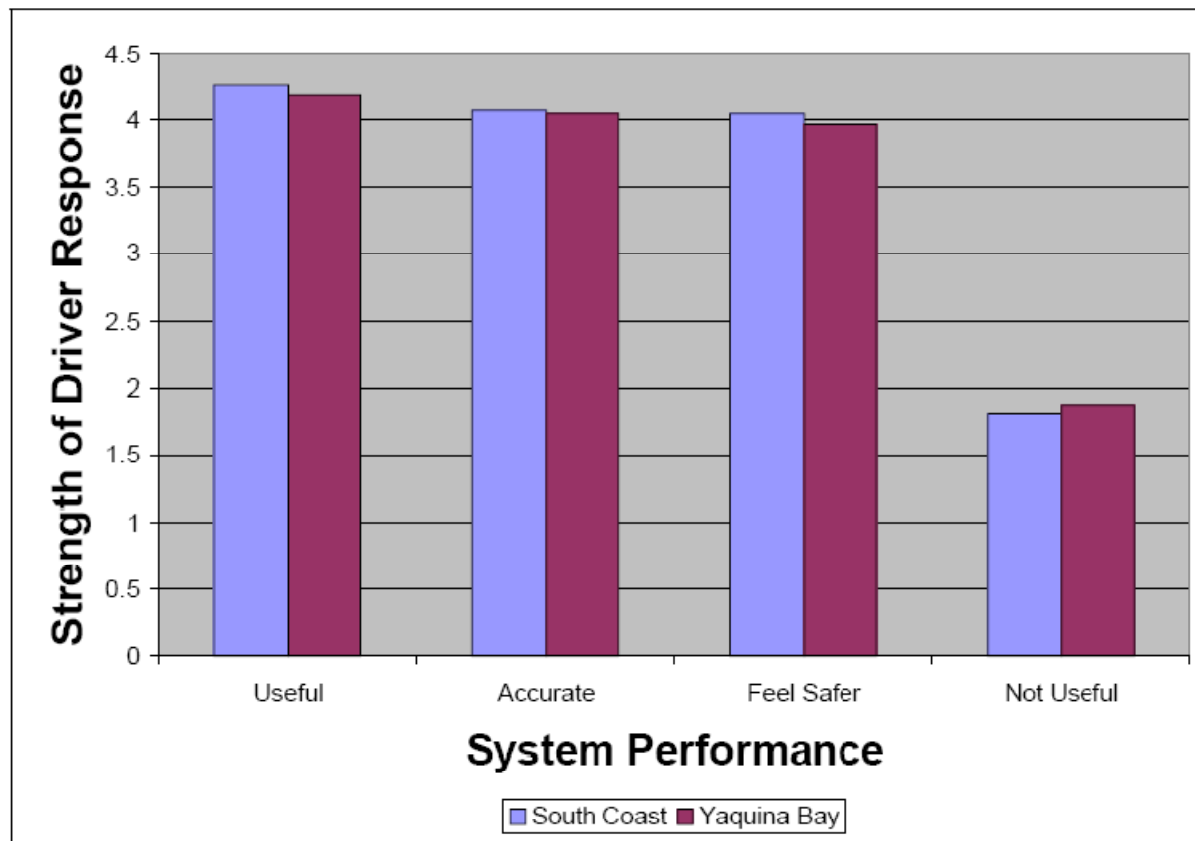
Figure 8-2. Perception of AWSS Performance by Respondents

Perception of performance

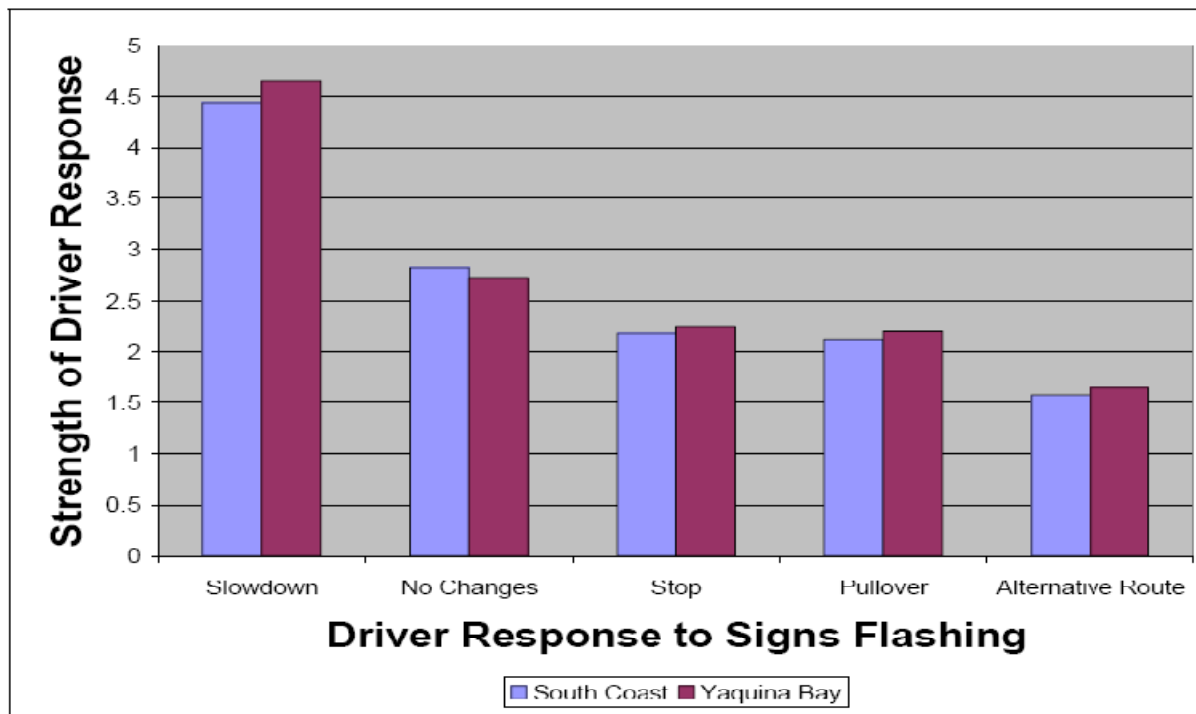
Figure 8-1. Stated Response to AWWWS Warnings by Respondents

Driver response to warning

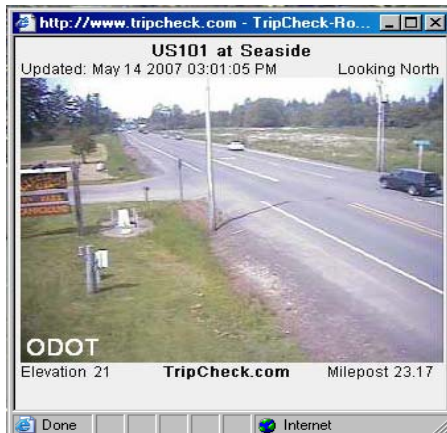
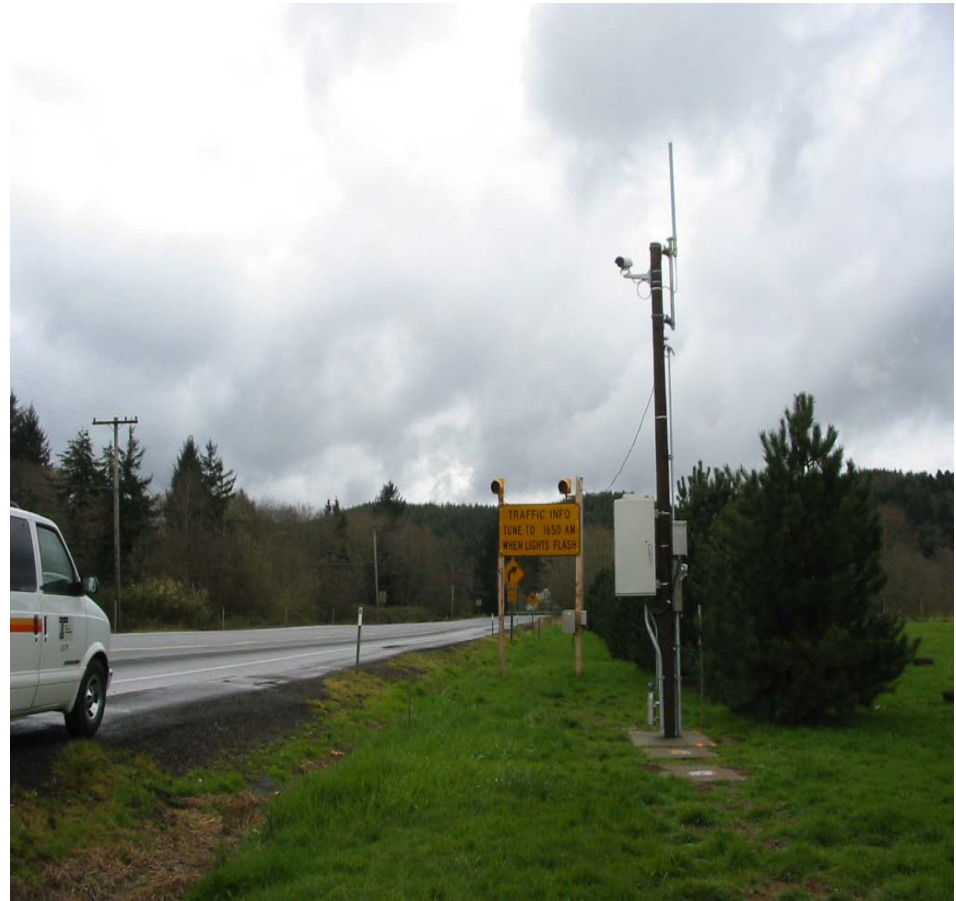
Seaside Flood Warning System

- Monitors water at low points in road (EoP and crown)
- Signs at each end of 5 mile corridor

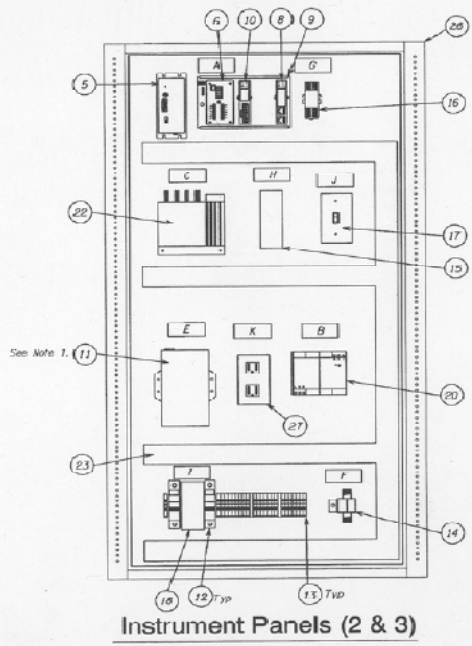
Drawing – Panel Layout

INSTRUMENT PANEL LAYOUT

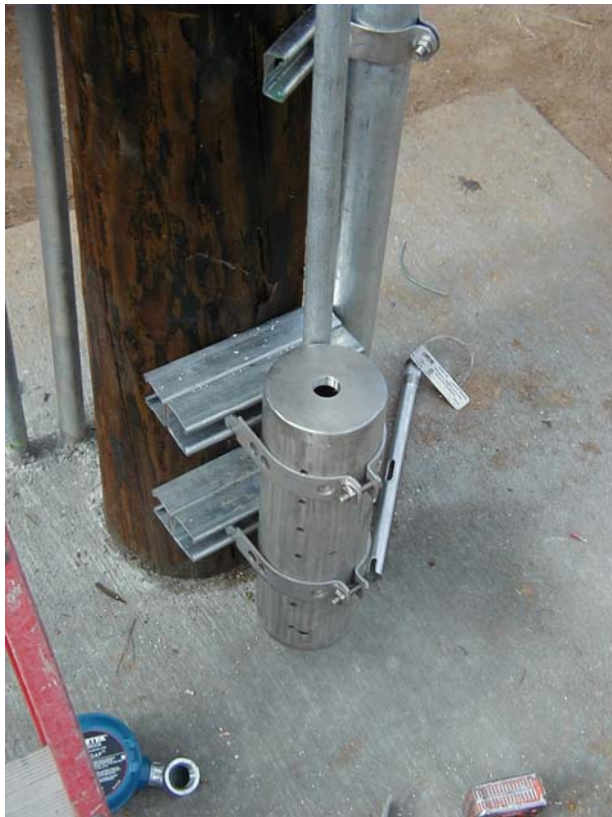
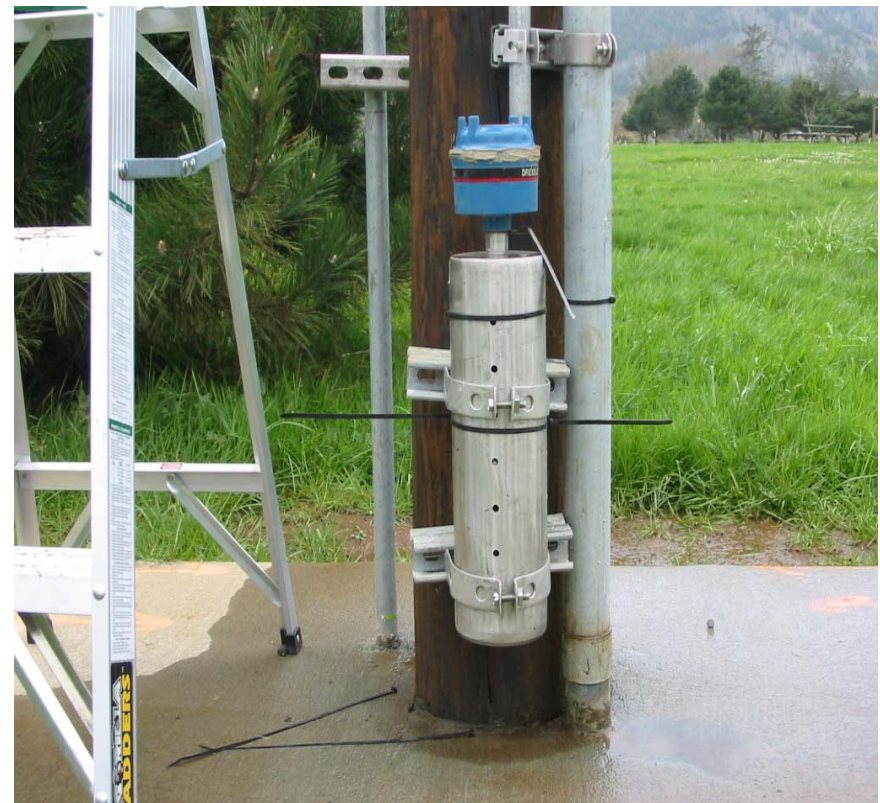
Pictures – Stillwell and ultrasonic level switches being installed

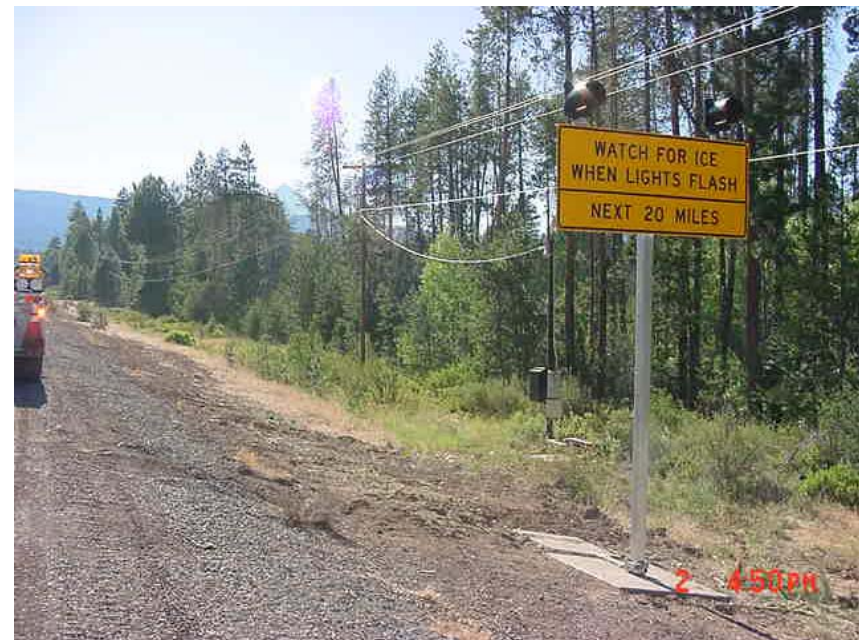
- Two winters of operation.
- STE allowed as a limited liability (pilot) project with research to determine effectiveness.
- If effective, STE wants statewide index established for determining other locations.
- Research of the systems effectiveness has not started. ODOT needs to install traffic count and speed equipment.
- TOC operators can override system, manually control signs through ScanWeb's device control. Will integrate into TOC software in the future.
- FP2000 sensors had to be re-installed due to paving project.

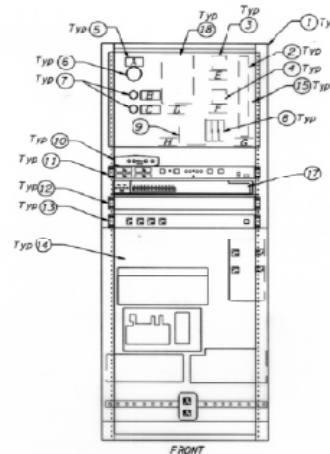
TRAFFIC GATE ENCLOSURE ASSEMBLY
System No. 2, Union Junction Interchange
